**INSTALLATION RESTORATION PROGRAM  
TWIN CITIES ARMY AMMUNITION PLANT**

**FISCAL YEAR 1999 ANNUAL PERFORMANCE REPORT**

**OCTOBER 2000  
FINAL REPORT**

Subject: Consistency Test for the Fiscal Year 1999 Annual Performance Report, Twin Cities Army Ammunition Plant, Arden Hills, Minnesota

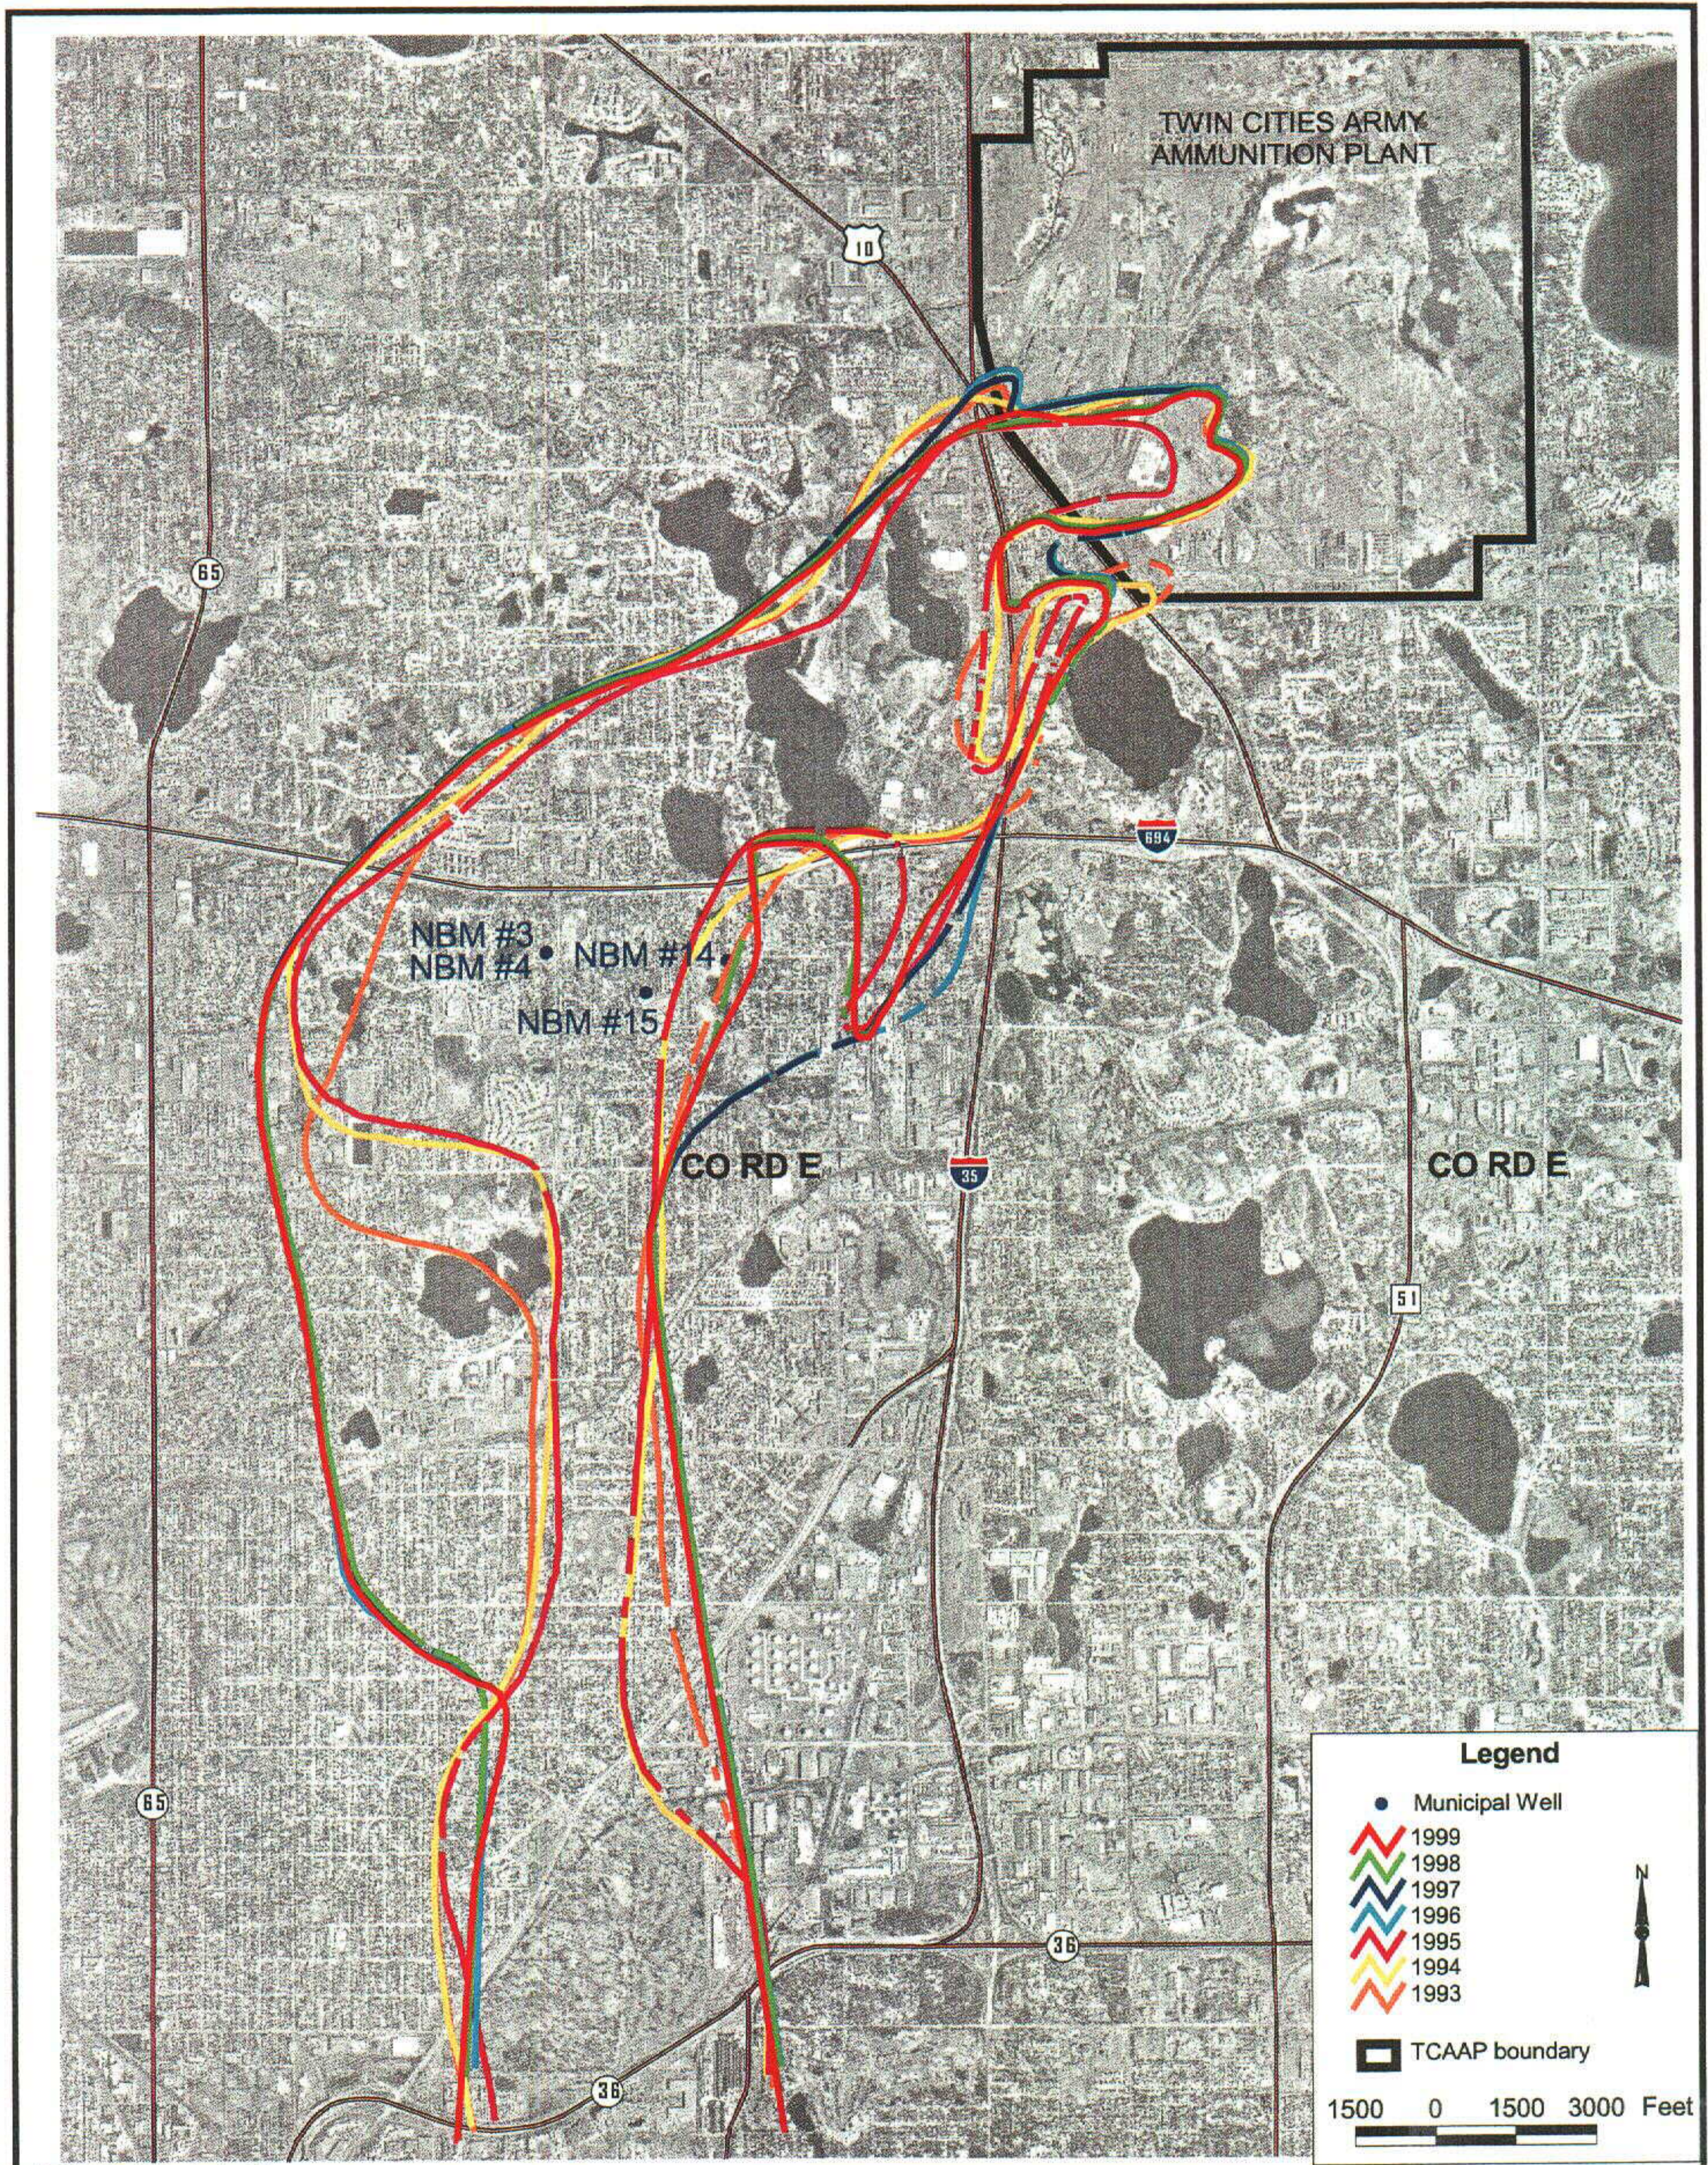
TWIN CITIES ARMY AMMUNITION PLANT  
 Upper Unit 4  
 1 ug/l Trichloroethene Isoconcentration Map

7. As noted earlier in Section 3.0, Figure 3-1 shows that the 1  $\mu\text{g/l}$  contour did not appreciably change for Upper Unit 4. The 10  $\mu\text{g/l}$  contour also did not change significantly.
8. With respect to the Jordan, near the TCAAP boundary at PJ#806, the trichloroethene concentration decreased from 420 to 300  $\mu\text{g/l}$ . In the vicinity of the OU1 extraction wells, from west to east, the trichloroethene concentrations were:

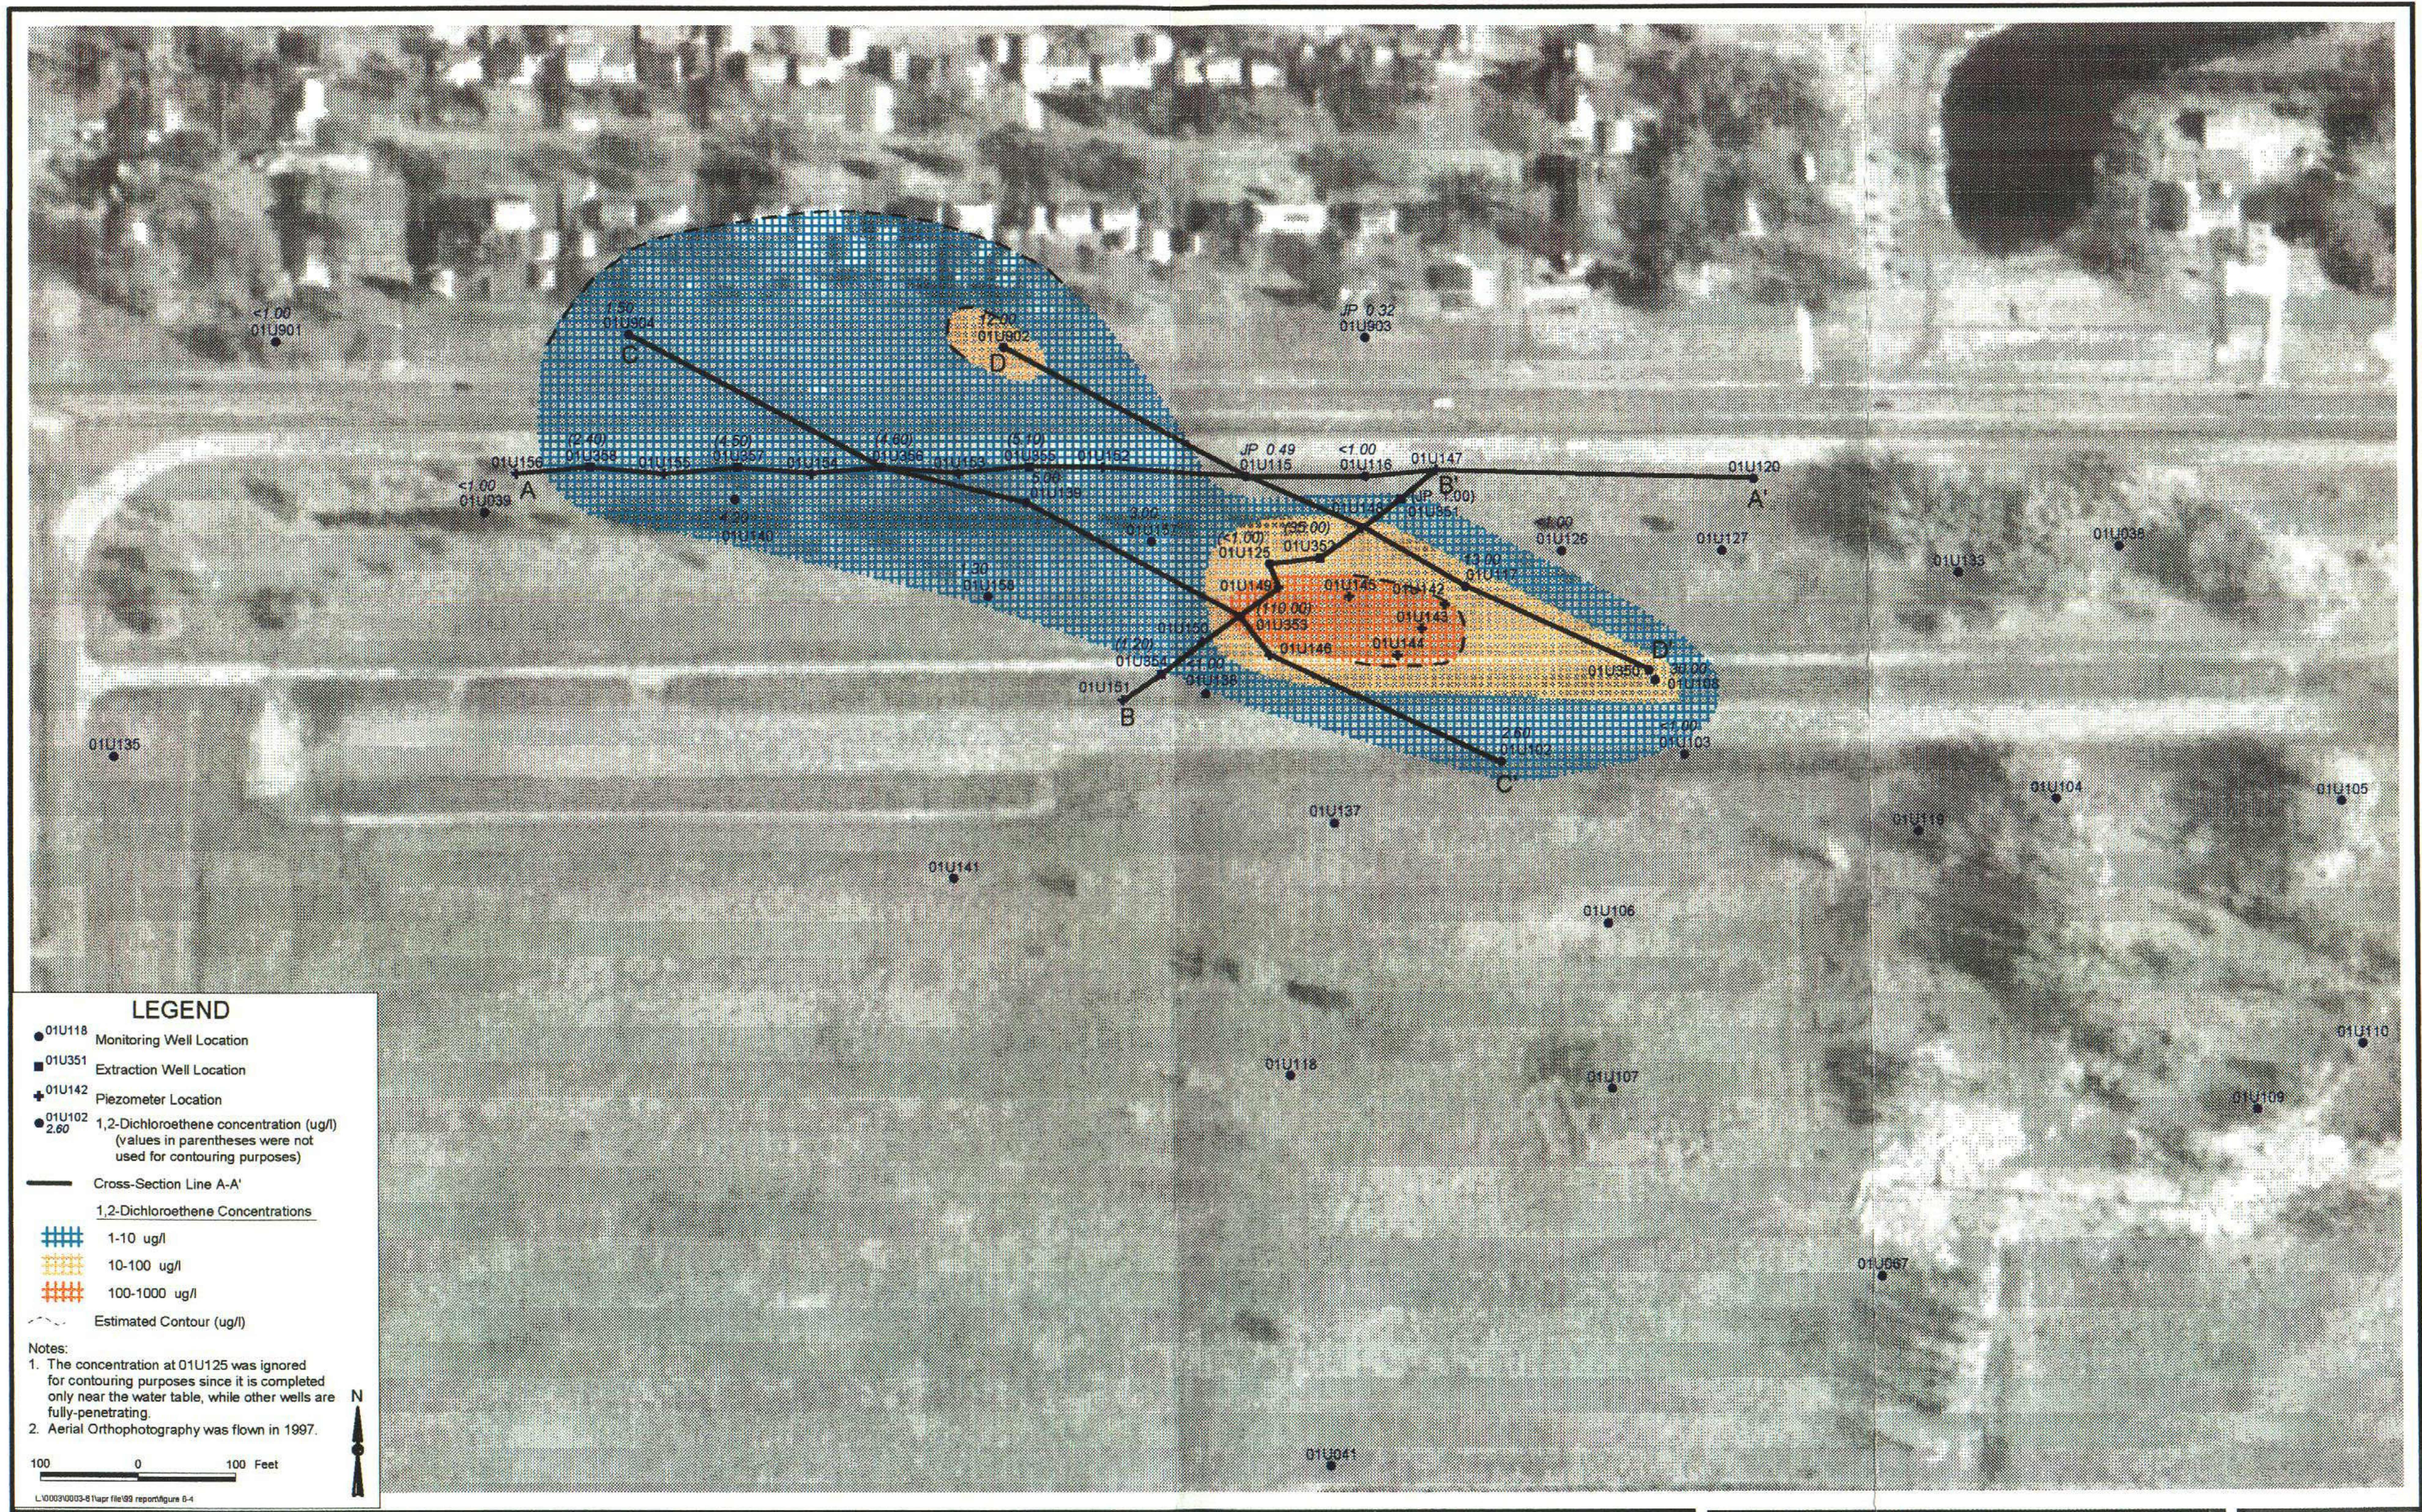
OCT 2000  
 Figure 6-4

As a different perspective on the contaminant conditions, Figure 6-2 presents several cross-sections with 1,2-dichloroethene concentrations and contours showing the same changes described above.
