Twin Cities Army Ammunition Plant

**FISCAL YEAR 2018 ANNUAL  
PERFORMANCE REPORT**

New Brighton/Arden Hills Superfund Site

11 June 2019

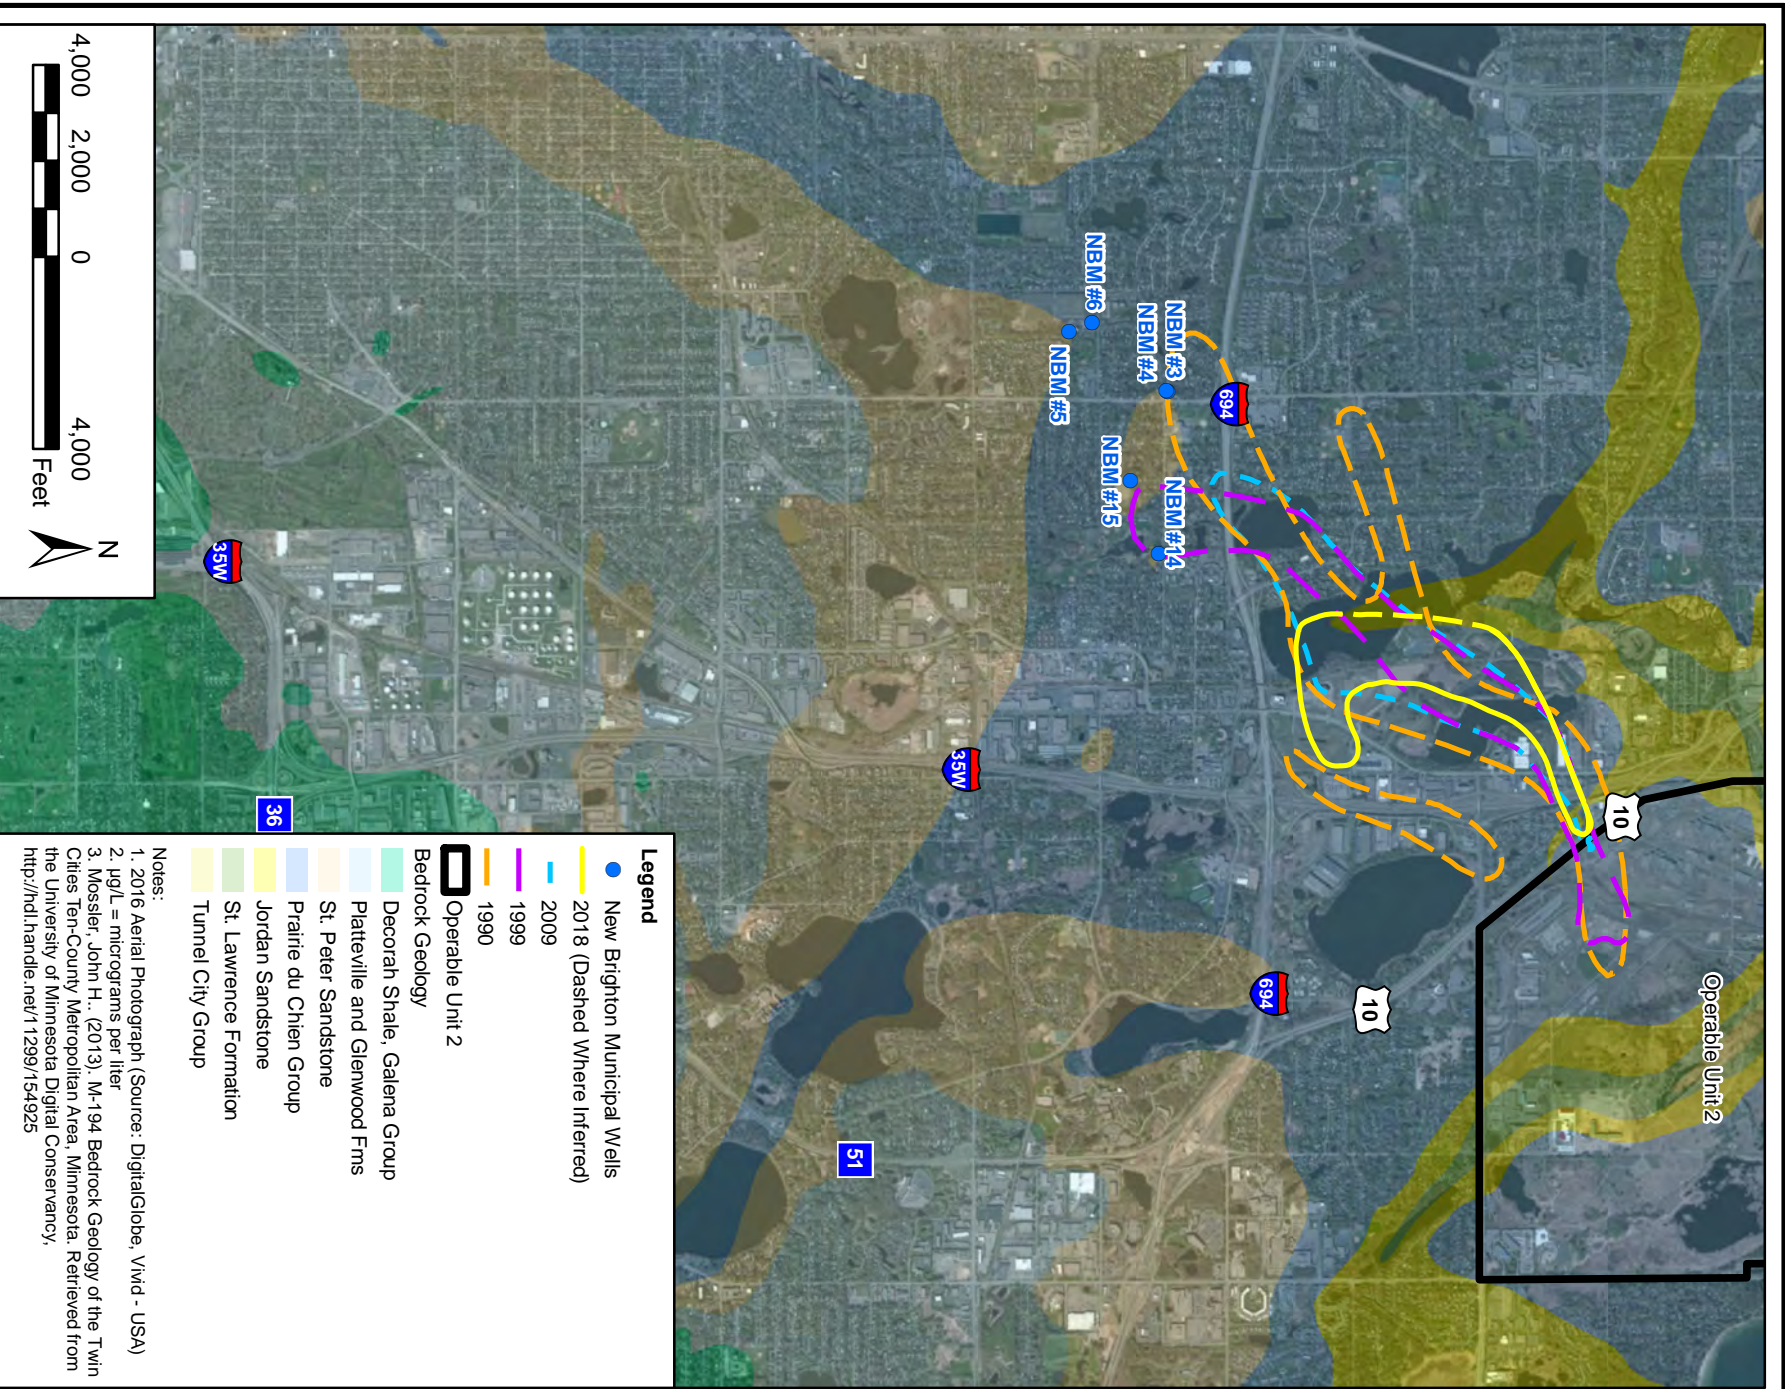
FY 2018  
 Figure 3-9

analysis below); as [Figure 3-1](#) and [Figure 3-9](#) show, the plume footprint remains similar to 2009. A slight northward shift of the 1 µg/L and 100 µg/L TCE contours north of the NBCGRS can be seen on the northwest edge of the plume, likely a result of the NBCGRS remedy time-out since April 2015. This shift was first observed following the FY 2015 sampling event and was observed slightly farther north again in FY 2016. Additional sampling will be needed to see if the trend continues, and to see if the west edge of the plume in areas south of the NBCGRS also begin to show a similar trend. Other differences between 2009 and 2018 plumes are due to plume reinterpretation by JV as part of the OU Remedy Review. The water level data from summer 2018 for Upper Unit 4 are presented as a potentiometric map on [Figure 3-10](#).

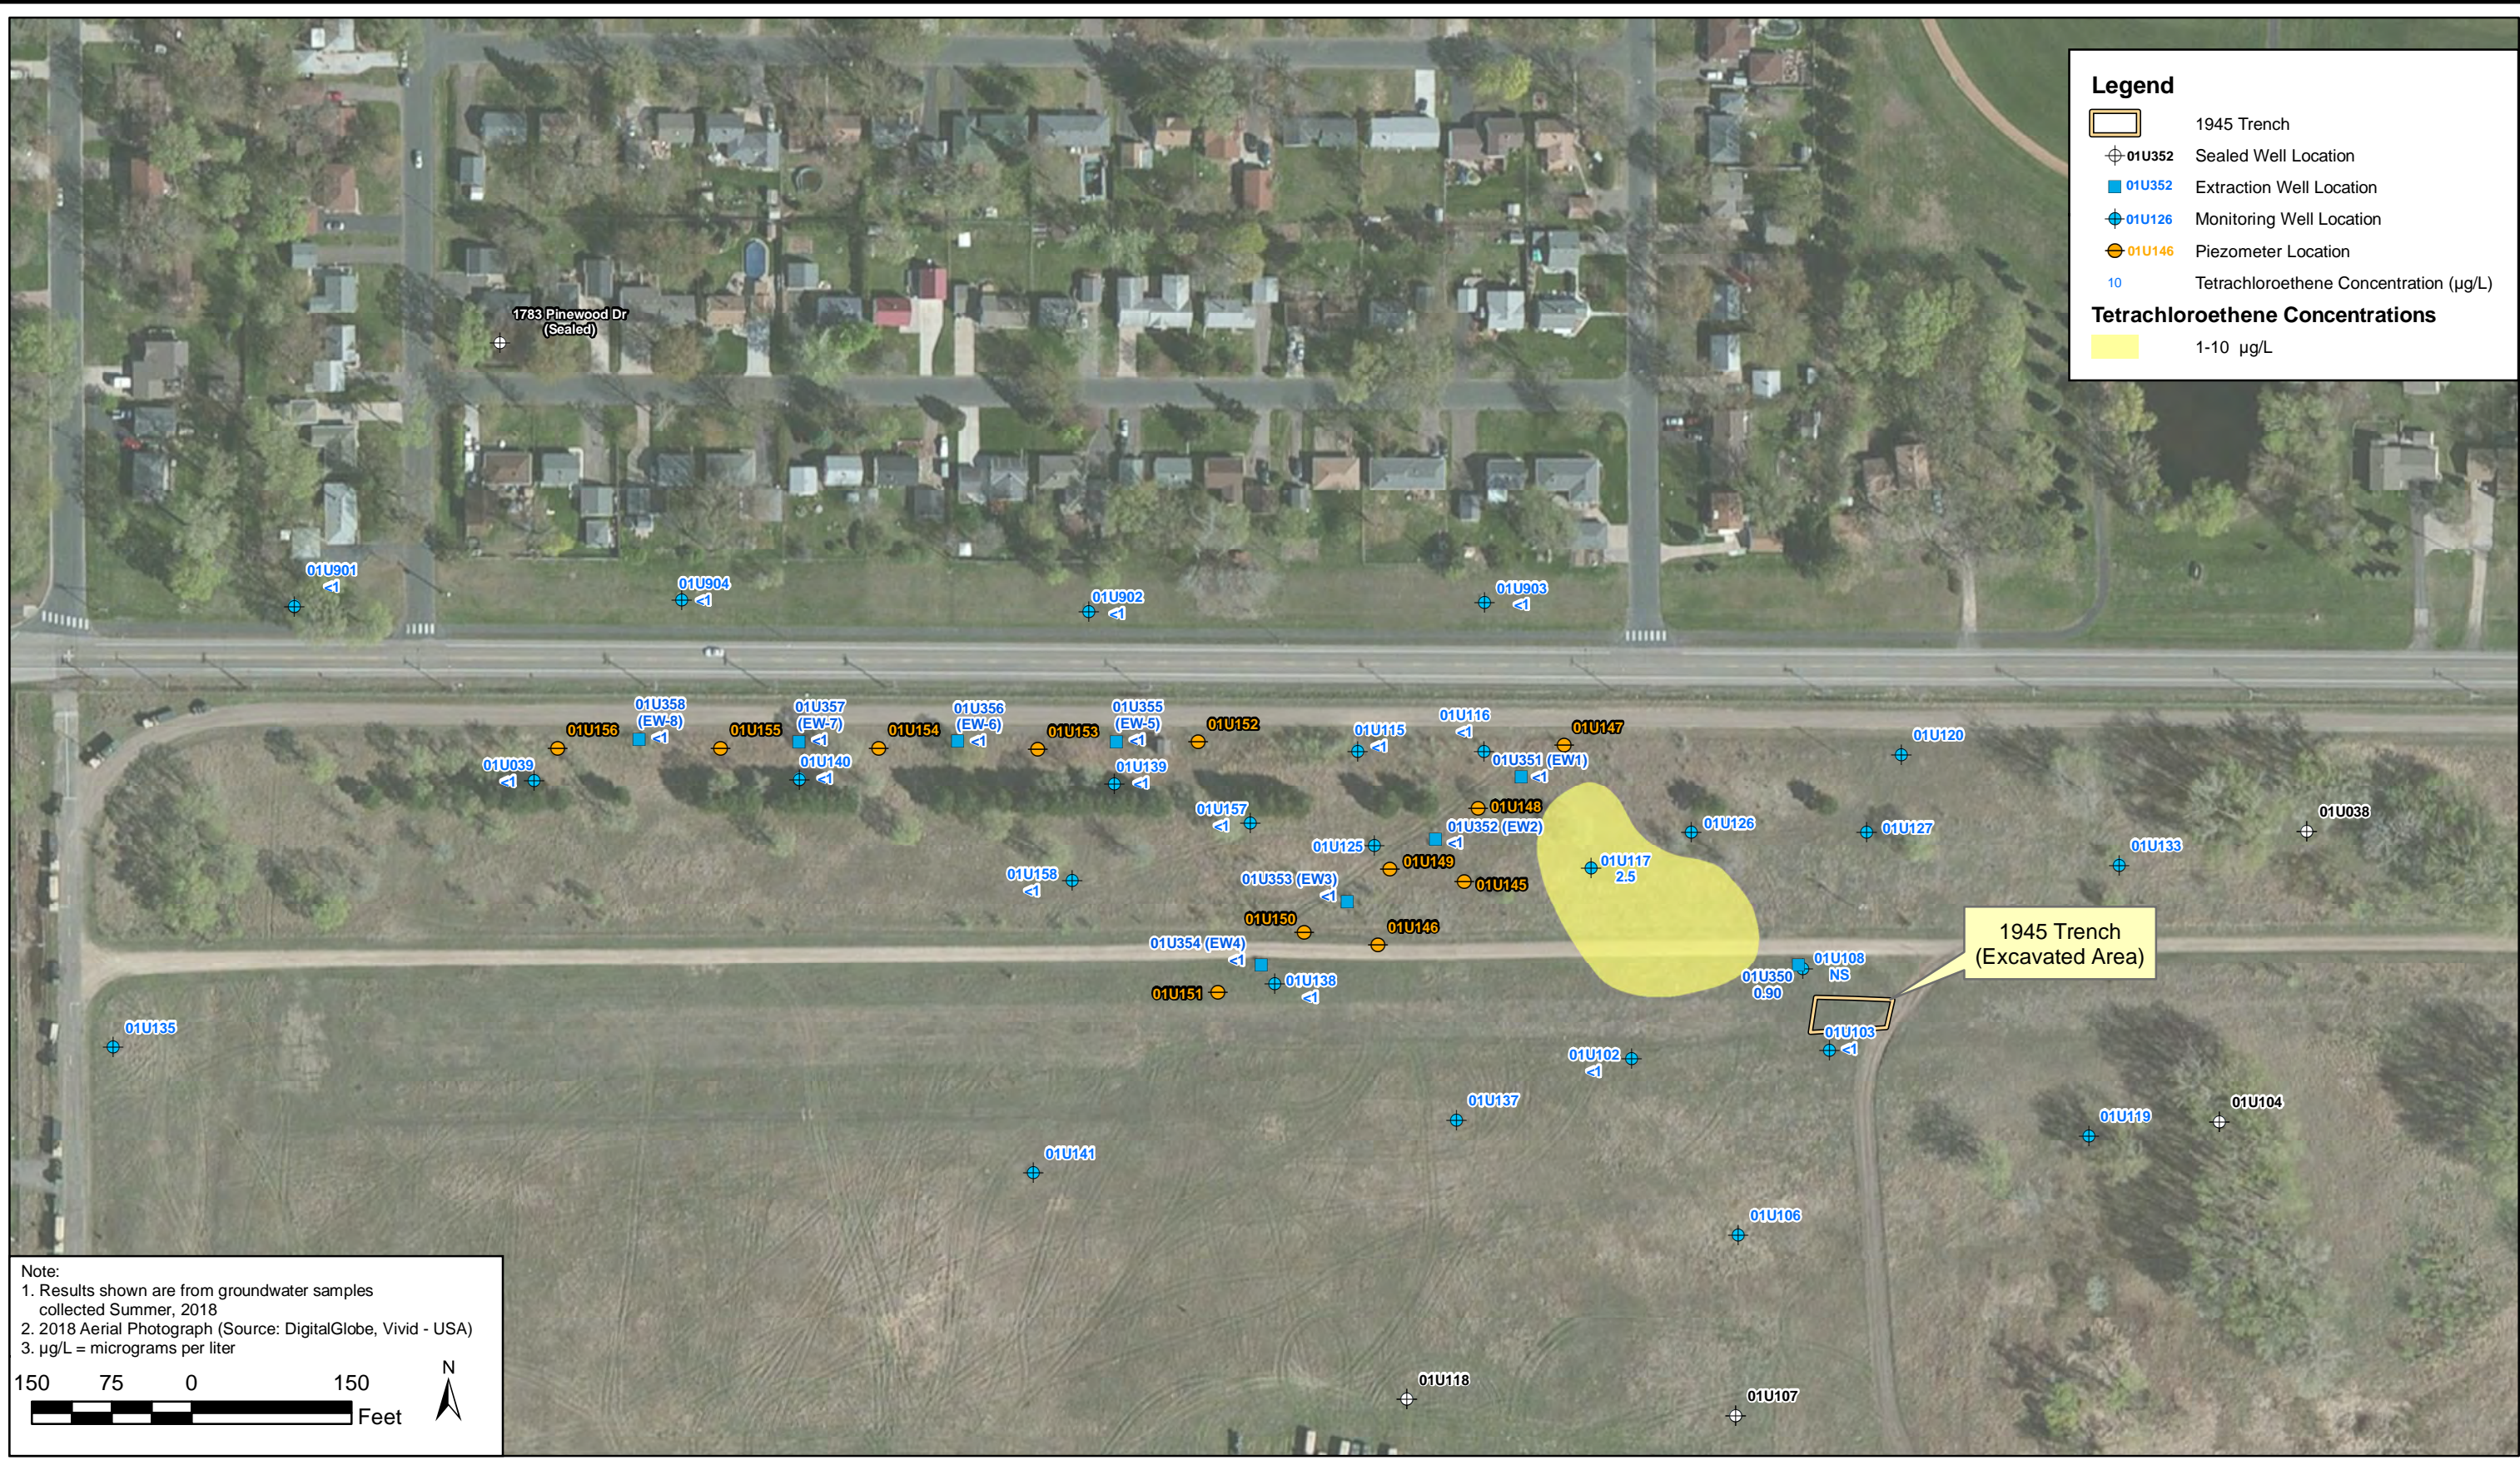
Figure 6-3

As evident in [Table 6-2](#), and on [Figures 6-3 and 6-4](#), PCE and TCE continue to be degraded to cis-1,2-DCE via natural attenuation. This degradation generally occurs within the distance between the source area and the first line of extraction wells (EW-1 through EW-4), with primarily only cis-1,2-DCE being detected downgradient of the first line of extraction wells. [Figure 6-6](#) shows the cis-1,2-DCE concentrations plotted on geologic cross sections to illustrate the vertical extent of contamination (the cross-section locations are illustrated on [Figure 6-4](#)). Cis-1,2-DCE continues to be degraded via an abiotic process as the plume migrates. The MPCA and USEPA initially evaluated attenuation at the site using computer modeling of contaminant degradation, as documented in Evaluation of Natural Attenuation of Chlorinated Solvents in Ground Water at the Twin Cities Army Ammunition Plant (MPCA and USEPA 2000). The MPCA conducted a follow-up microcosm study (unpublished), the results of which were presented to the Army and USEPA on April 10, 2007. The work conducted in this study
