**INSTALLATION RESTORATION PROGRAM  
TWIN CITIES ARMY AMMUNITION PLANT**

**FISCAL YEAR 1999 ANNUAL PERFORMANCE REPORT**

**OCTOBER 2000  
FINAL REPORT**

Subject: Consistency Test for the Fiscal Year 1999 Annual Performance Report, Twin Cities Army Ammunition Plant, Arden Hills, Minnesota

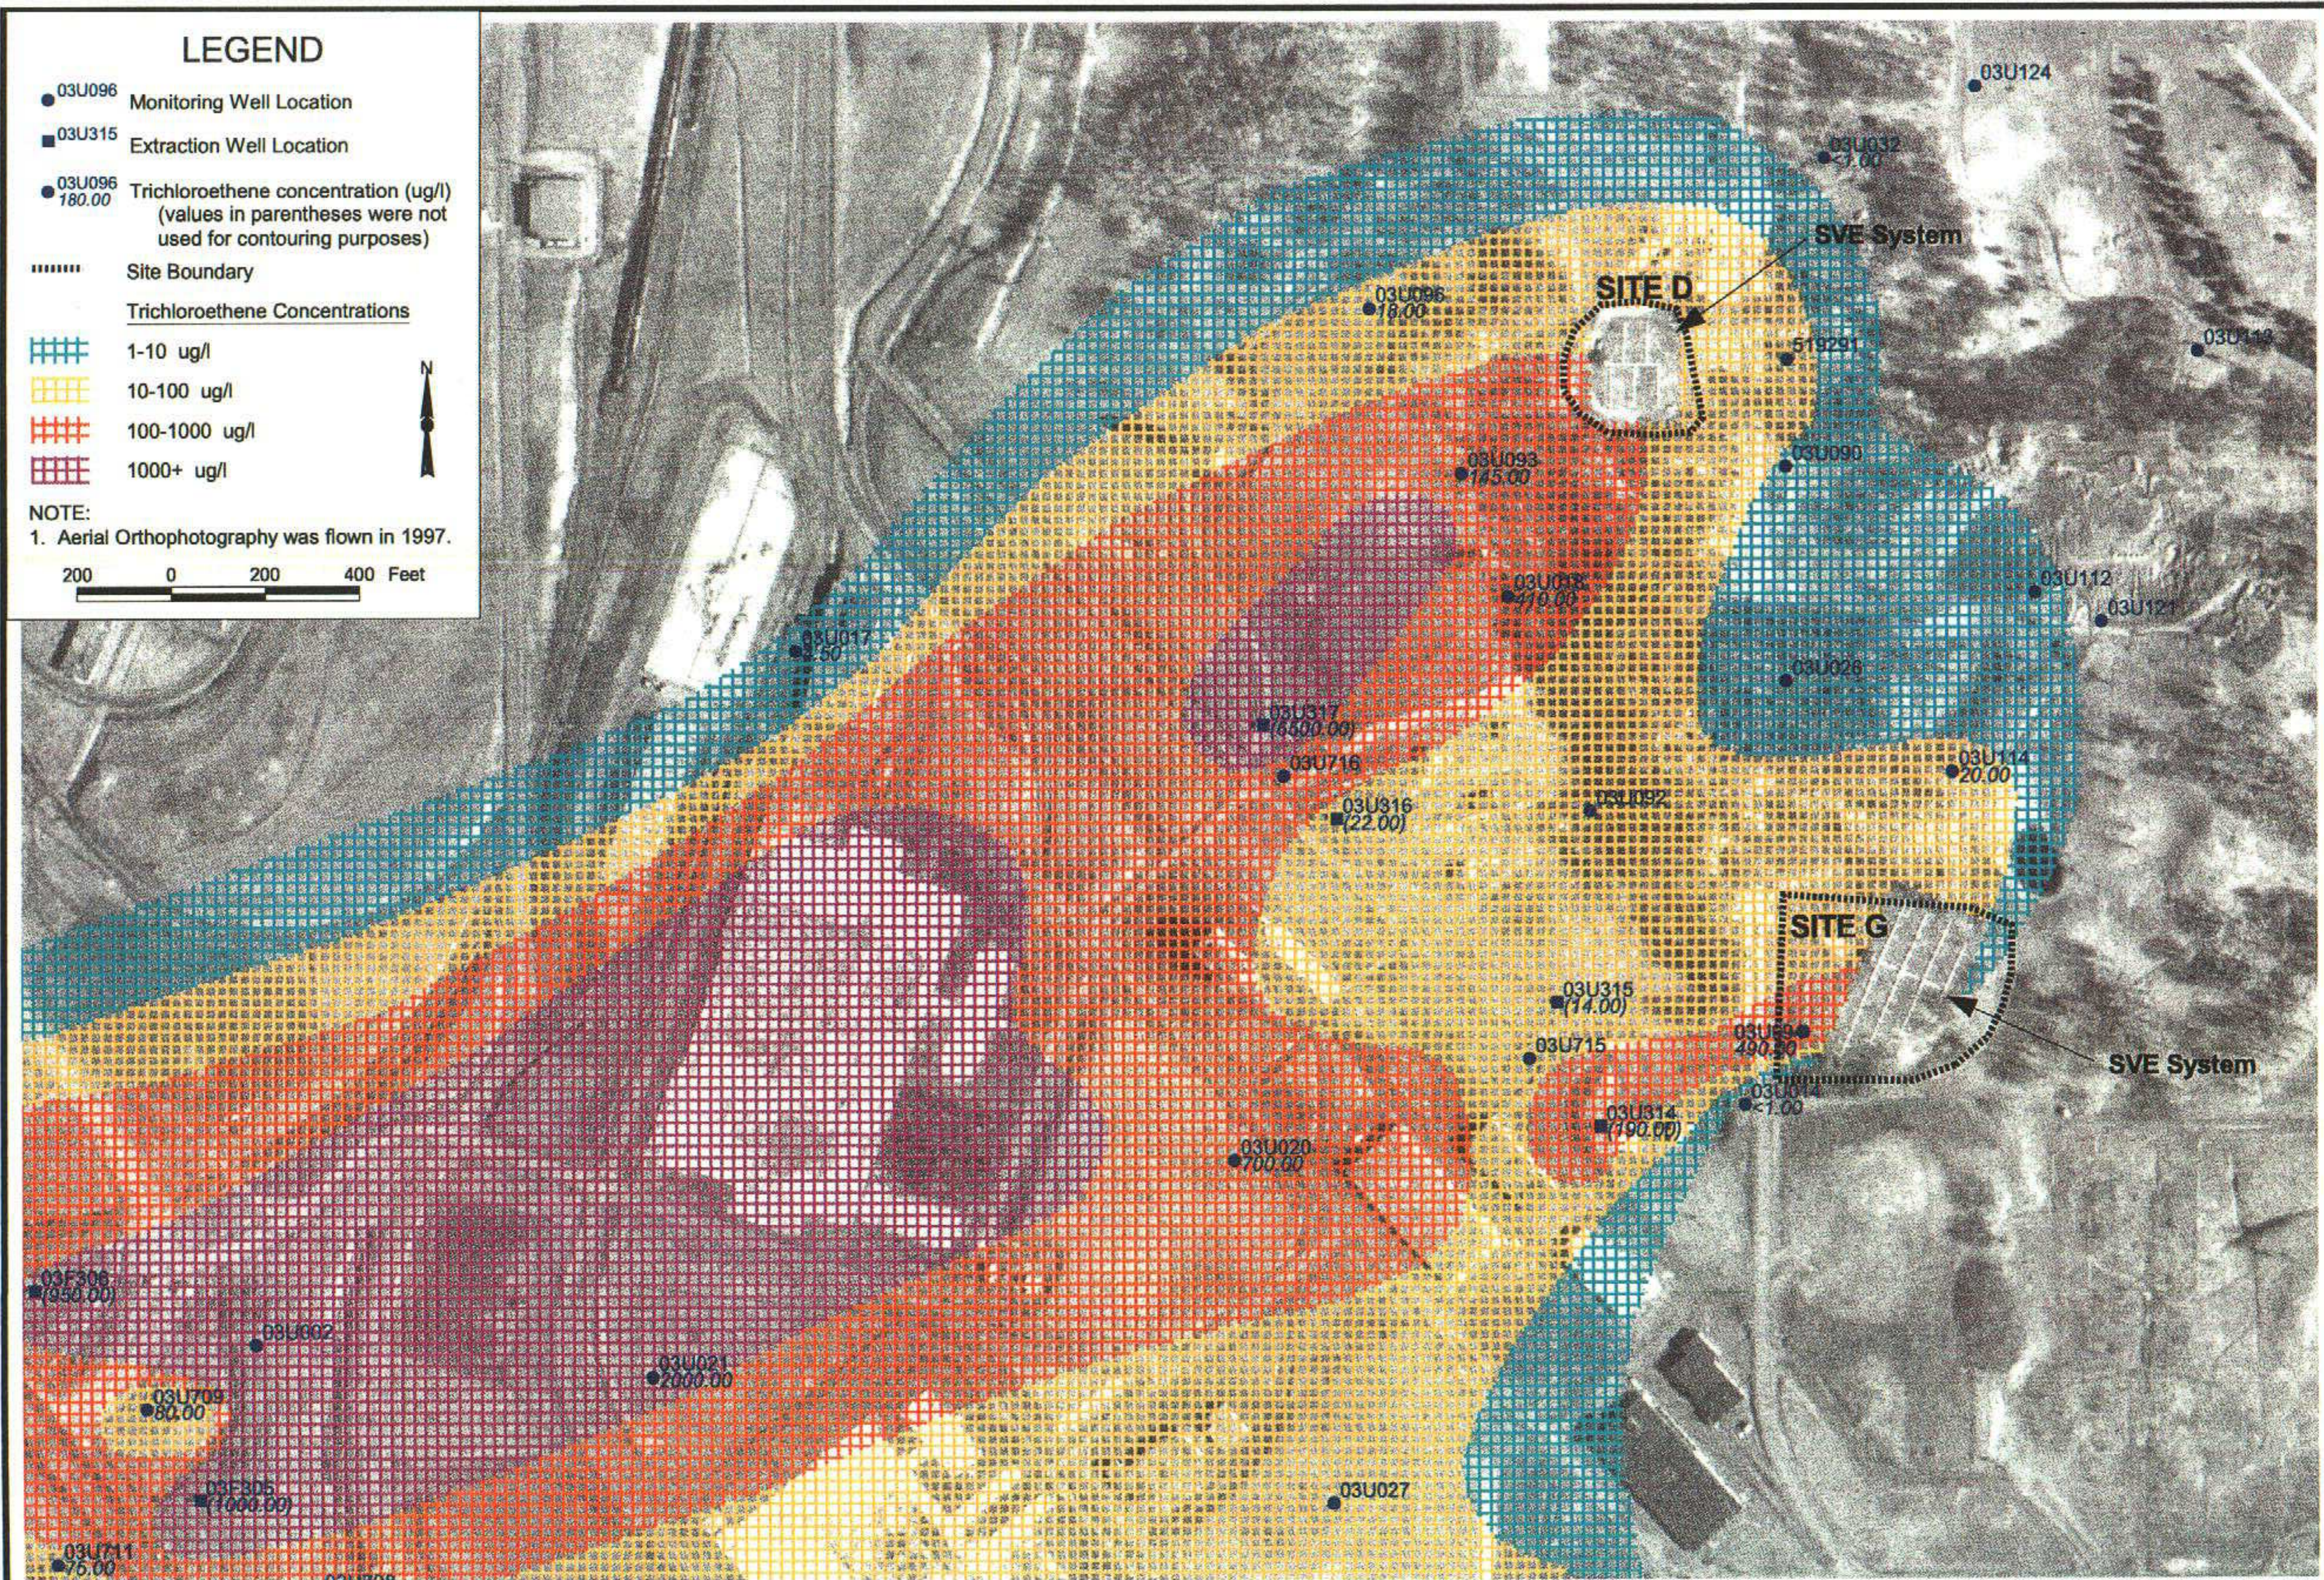
TWIN CITIES ARMY AMMUNITION PLANT  
Location of Wells Nearest to Sites D and G

Figure 5-1 shows the locations of the wells nearest to Site D (03U096, 03U093, and 03U018) and Site G (03U094 and 03U014), along with trichloroethene concentrations. Figures 5-2 through 5-6 present trend graphs for these wells.

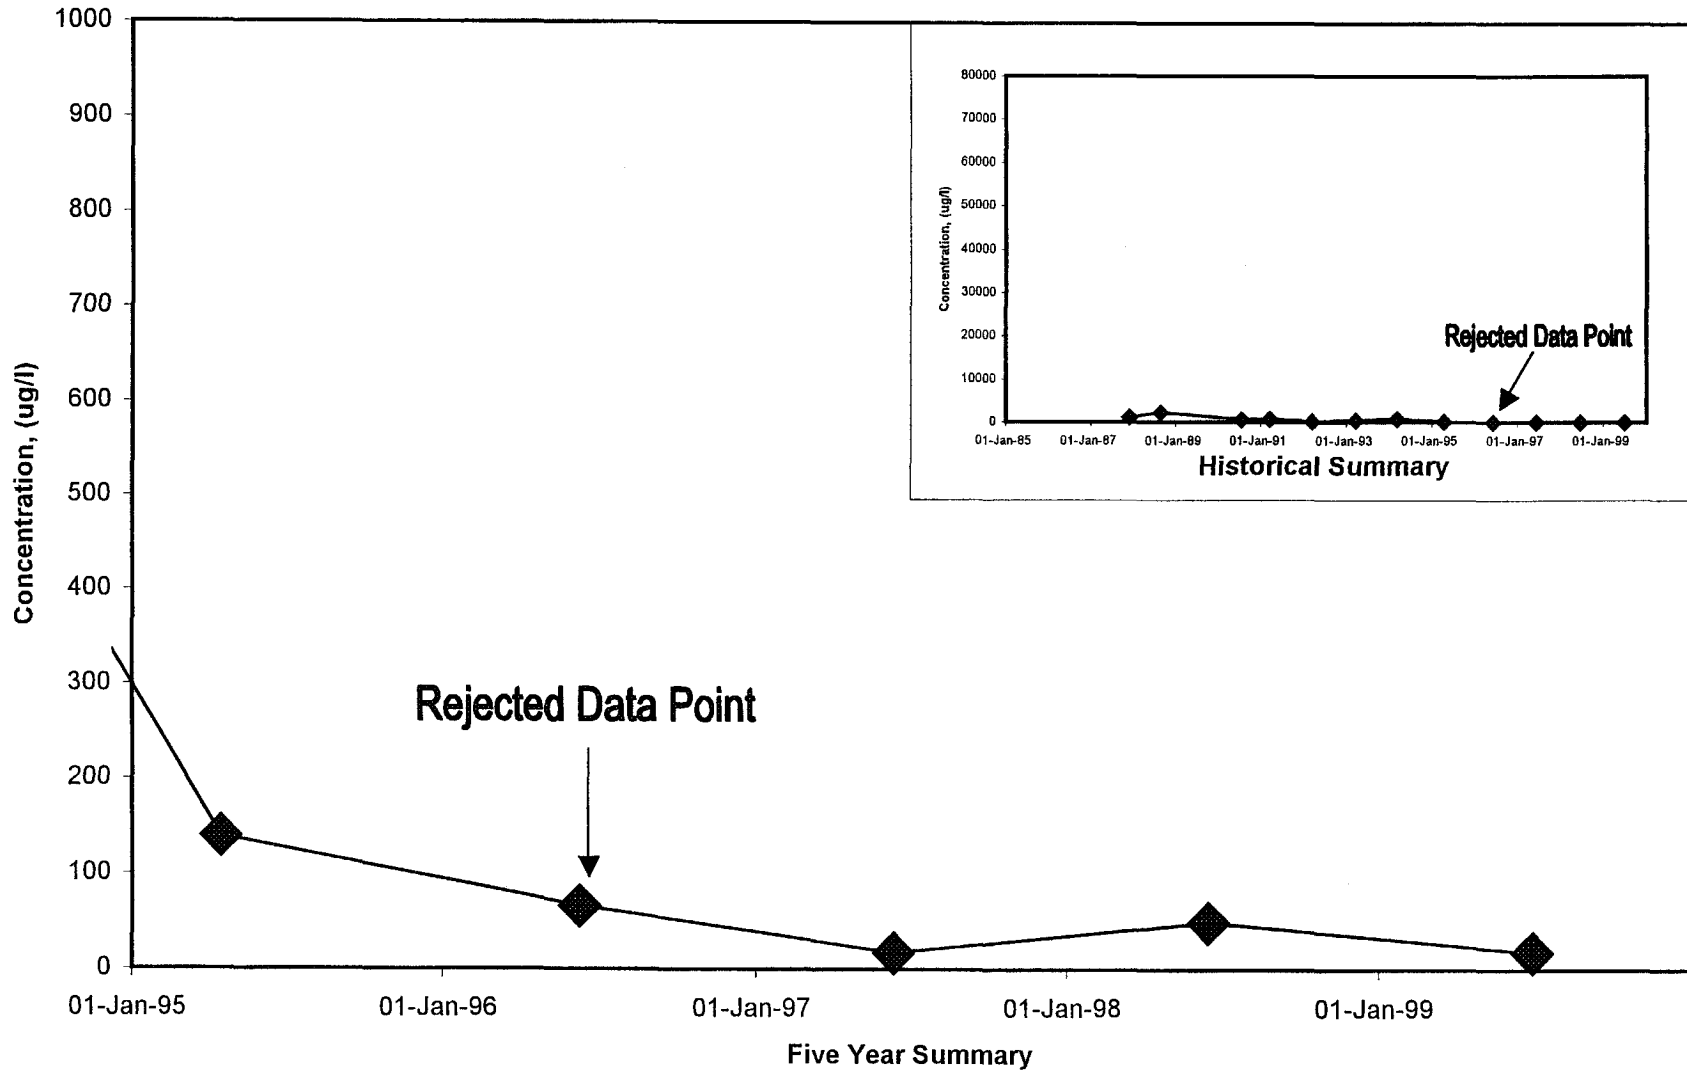
Figure 5-2  
Wenck Associates, Inc.  
N:\10003\61\FY99\APR\Figures\Fig\_5-2.xls\TNW-lmh

Downgradient of Site D at wells 03U096 (Figure 5-2) and 03U093 (Figure 5-3), the concentrations over the past five years show an overall decline. In contrast, at well 03U018 (Figure 5-4), the concentrations have increased the past two years, after previous declines. It is unclear if the increases are related to a "rebound effect" since the SVE system was shut-off, or if they are simply fluctuations in the data. The historical graph on Figure 5-4 shows fluctuations of similar or greater magnitude over the past 10 years.

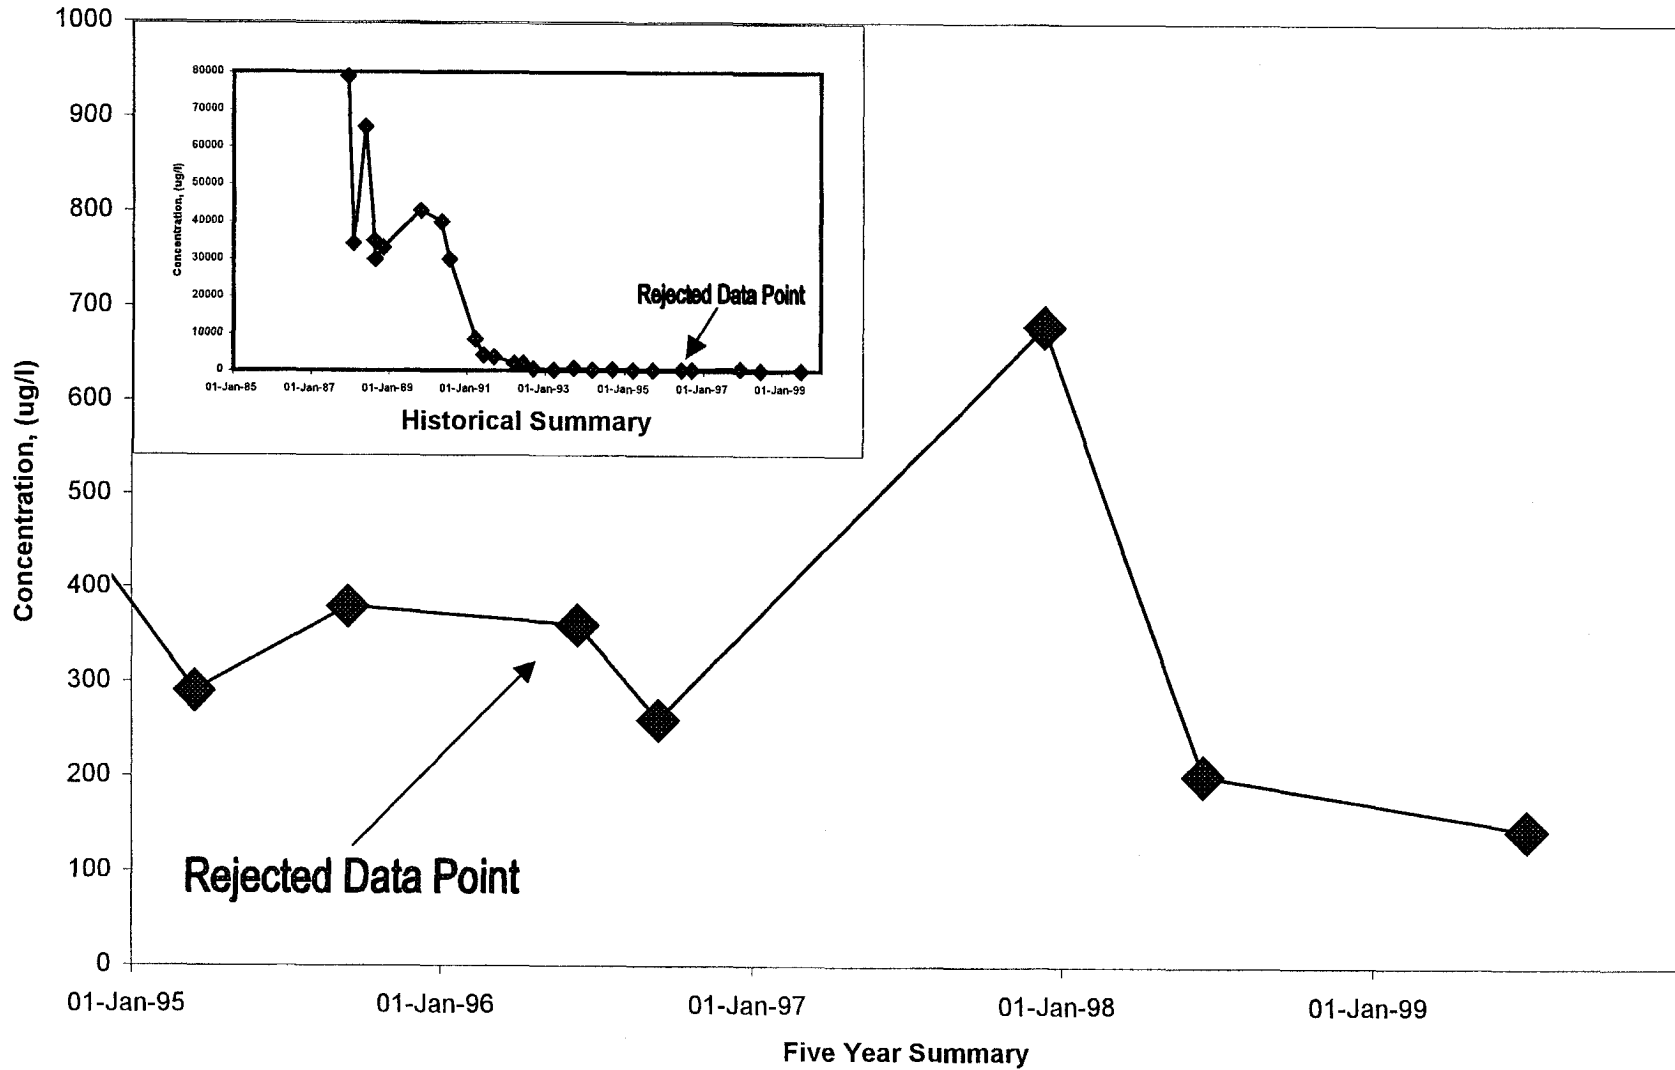
Figure 5-3

During the years of SVE operation (1986 – 1998), trichloroethene concentrations in groundwater decreased from 10,000's to less than 500 µg/l. The most dramatic improvement has been at well 03U093 (Figure 5-3). Overall, these results indicate that the SVE systems at Sites D and G effectively minimized (or eliminated) further contamination of the deep groundwater beneath these sites. However, the contaminant concentrations are still up to 100 times greater than the cleanup levels. This suggests the possibility of residual contamination, which is acting as an ongoing source for groundwater contamination. The residual source has not been defined and

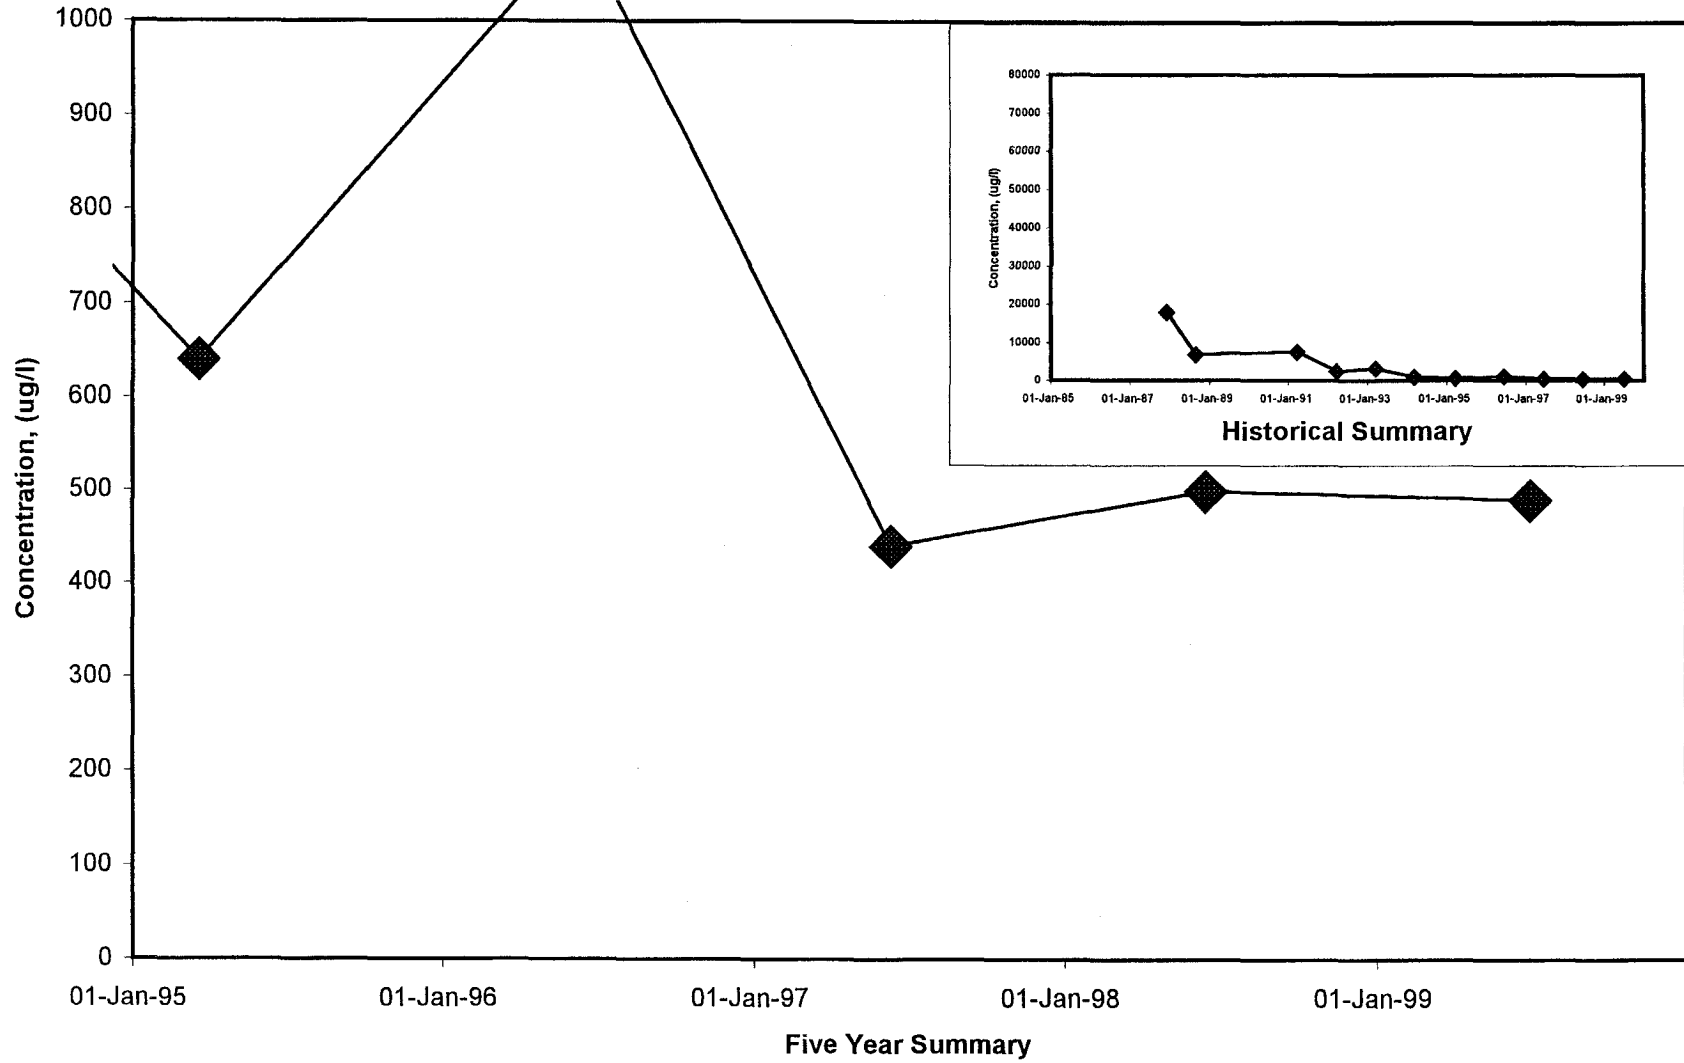
Figure 5-5  
Wenck Associates, Inc.  
N:\0003161\FY99APR\Figures\Fig\_5-5.xls\TNW-lmh

Downgradient of Site G, the concentrations have remained relatively stable at well 03U094 (Figure 5-5) the last three years. At well 03U014 (Figure 5-6), the concentrations have remained below the cleanup level the past four years.

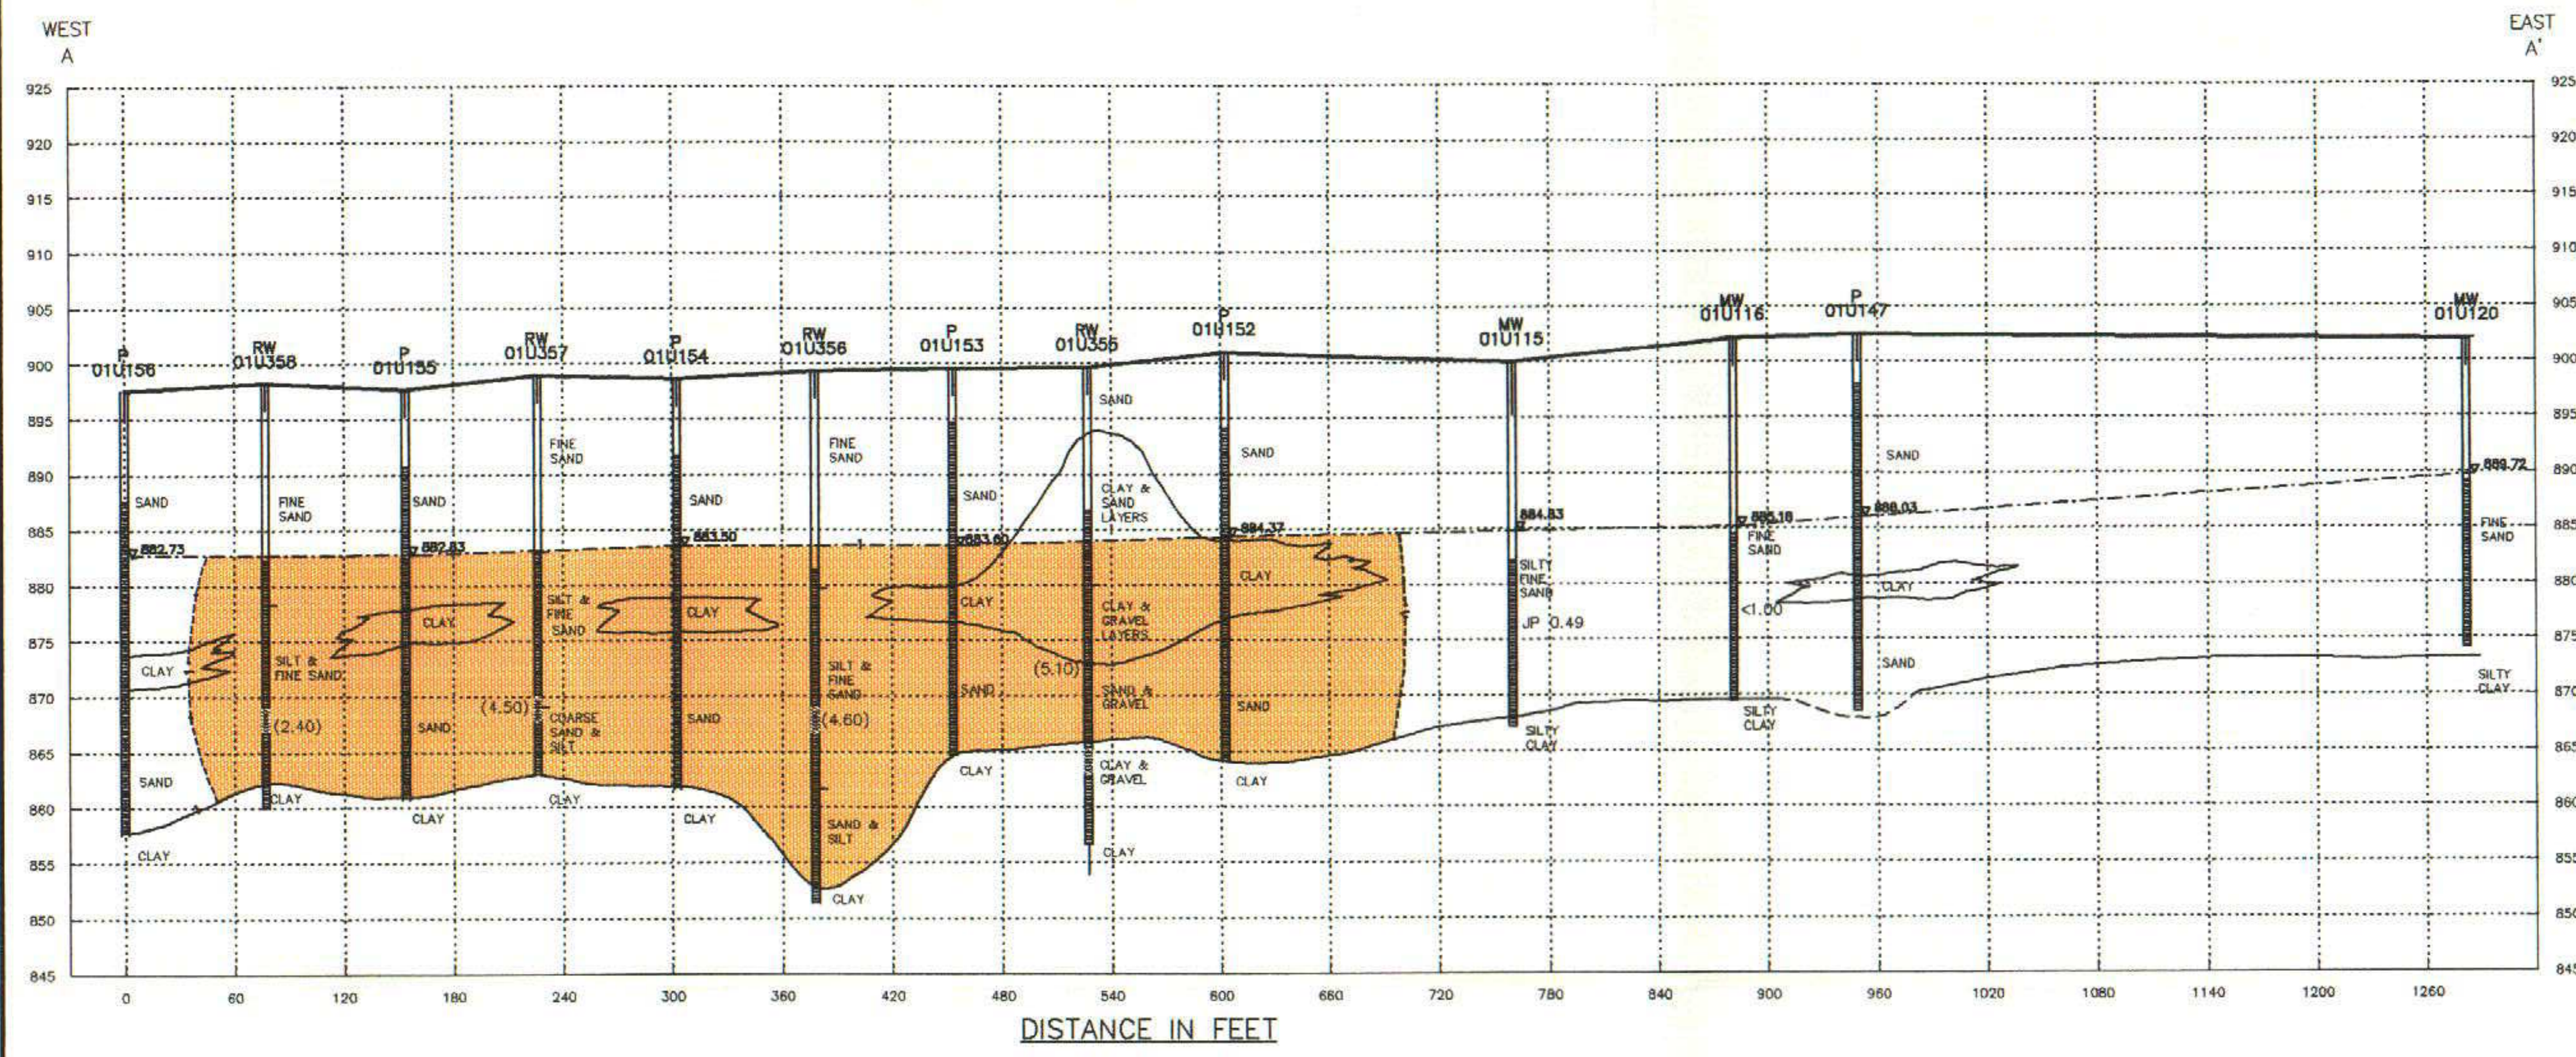
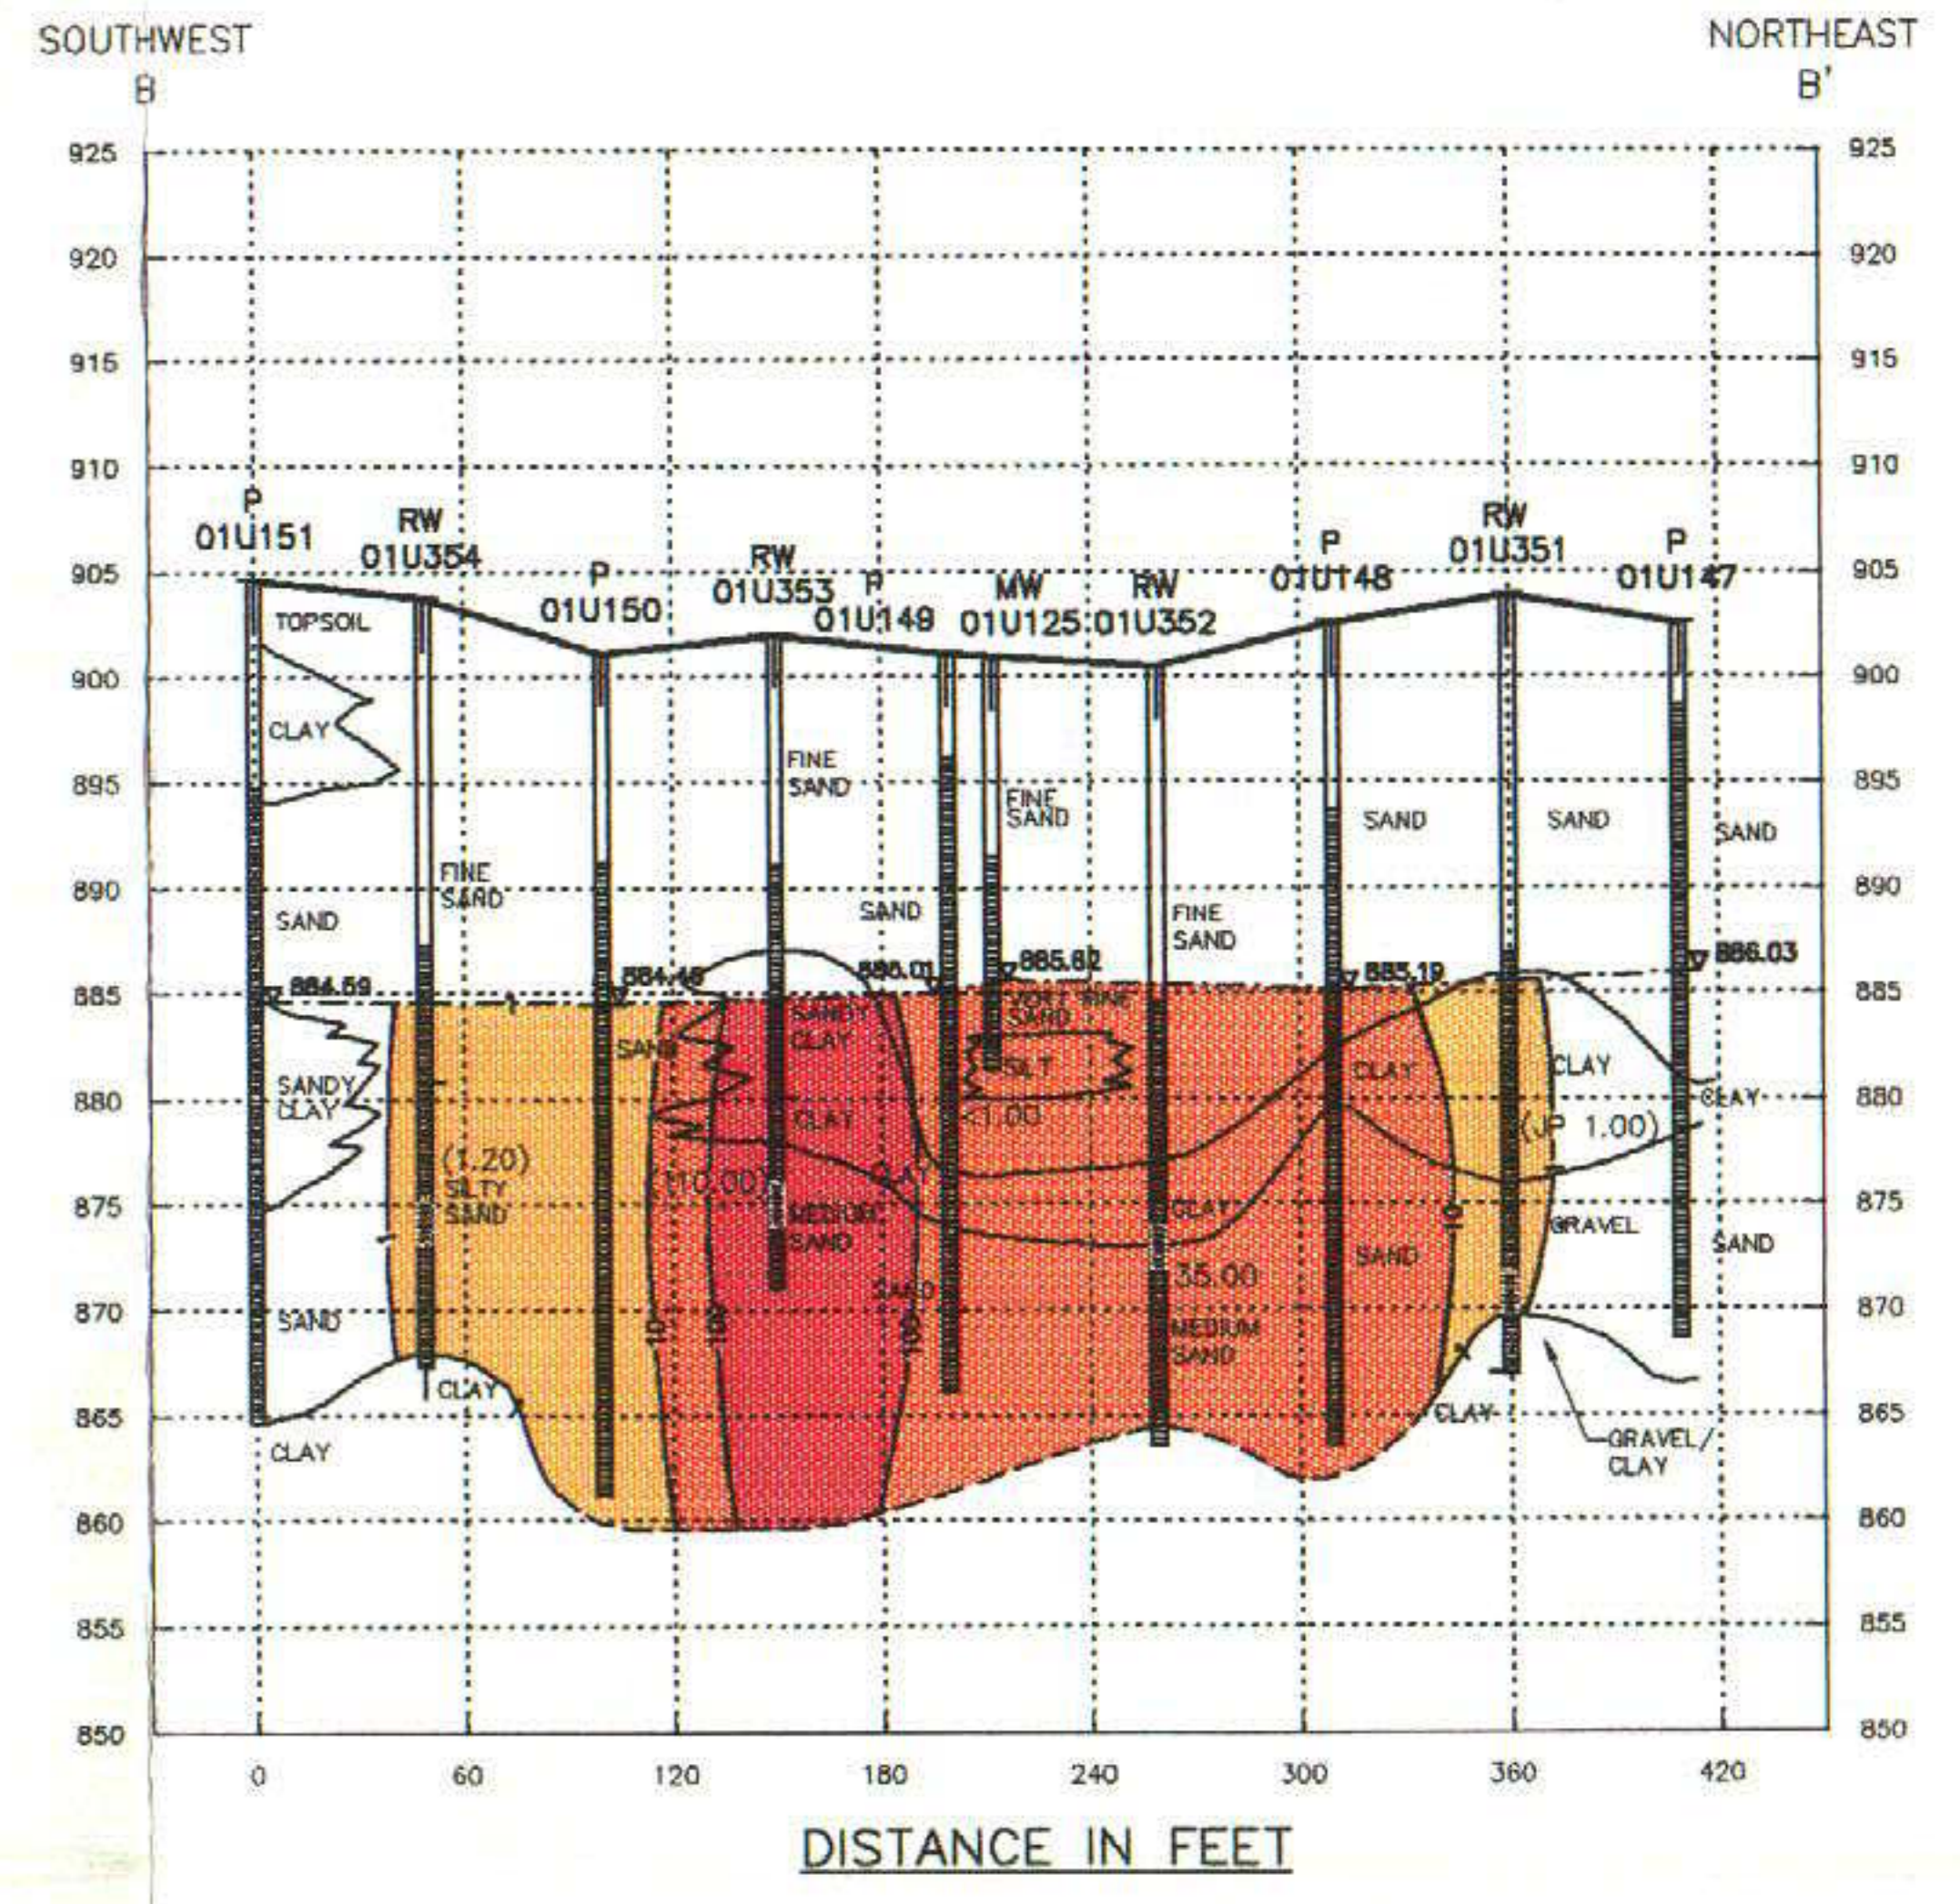
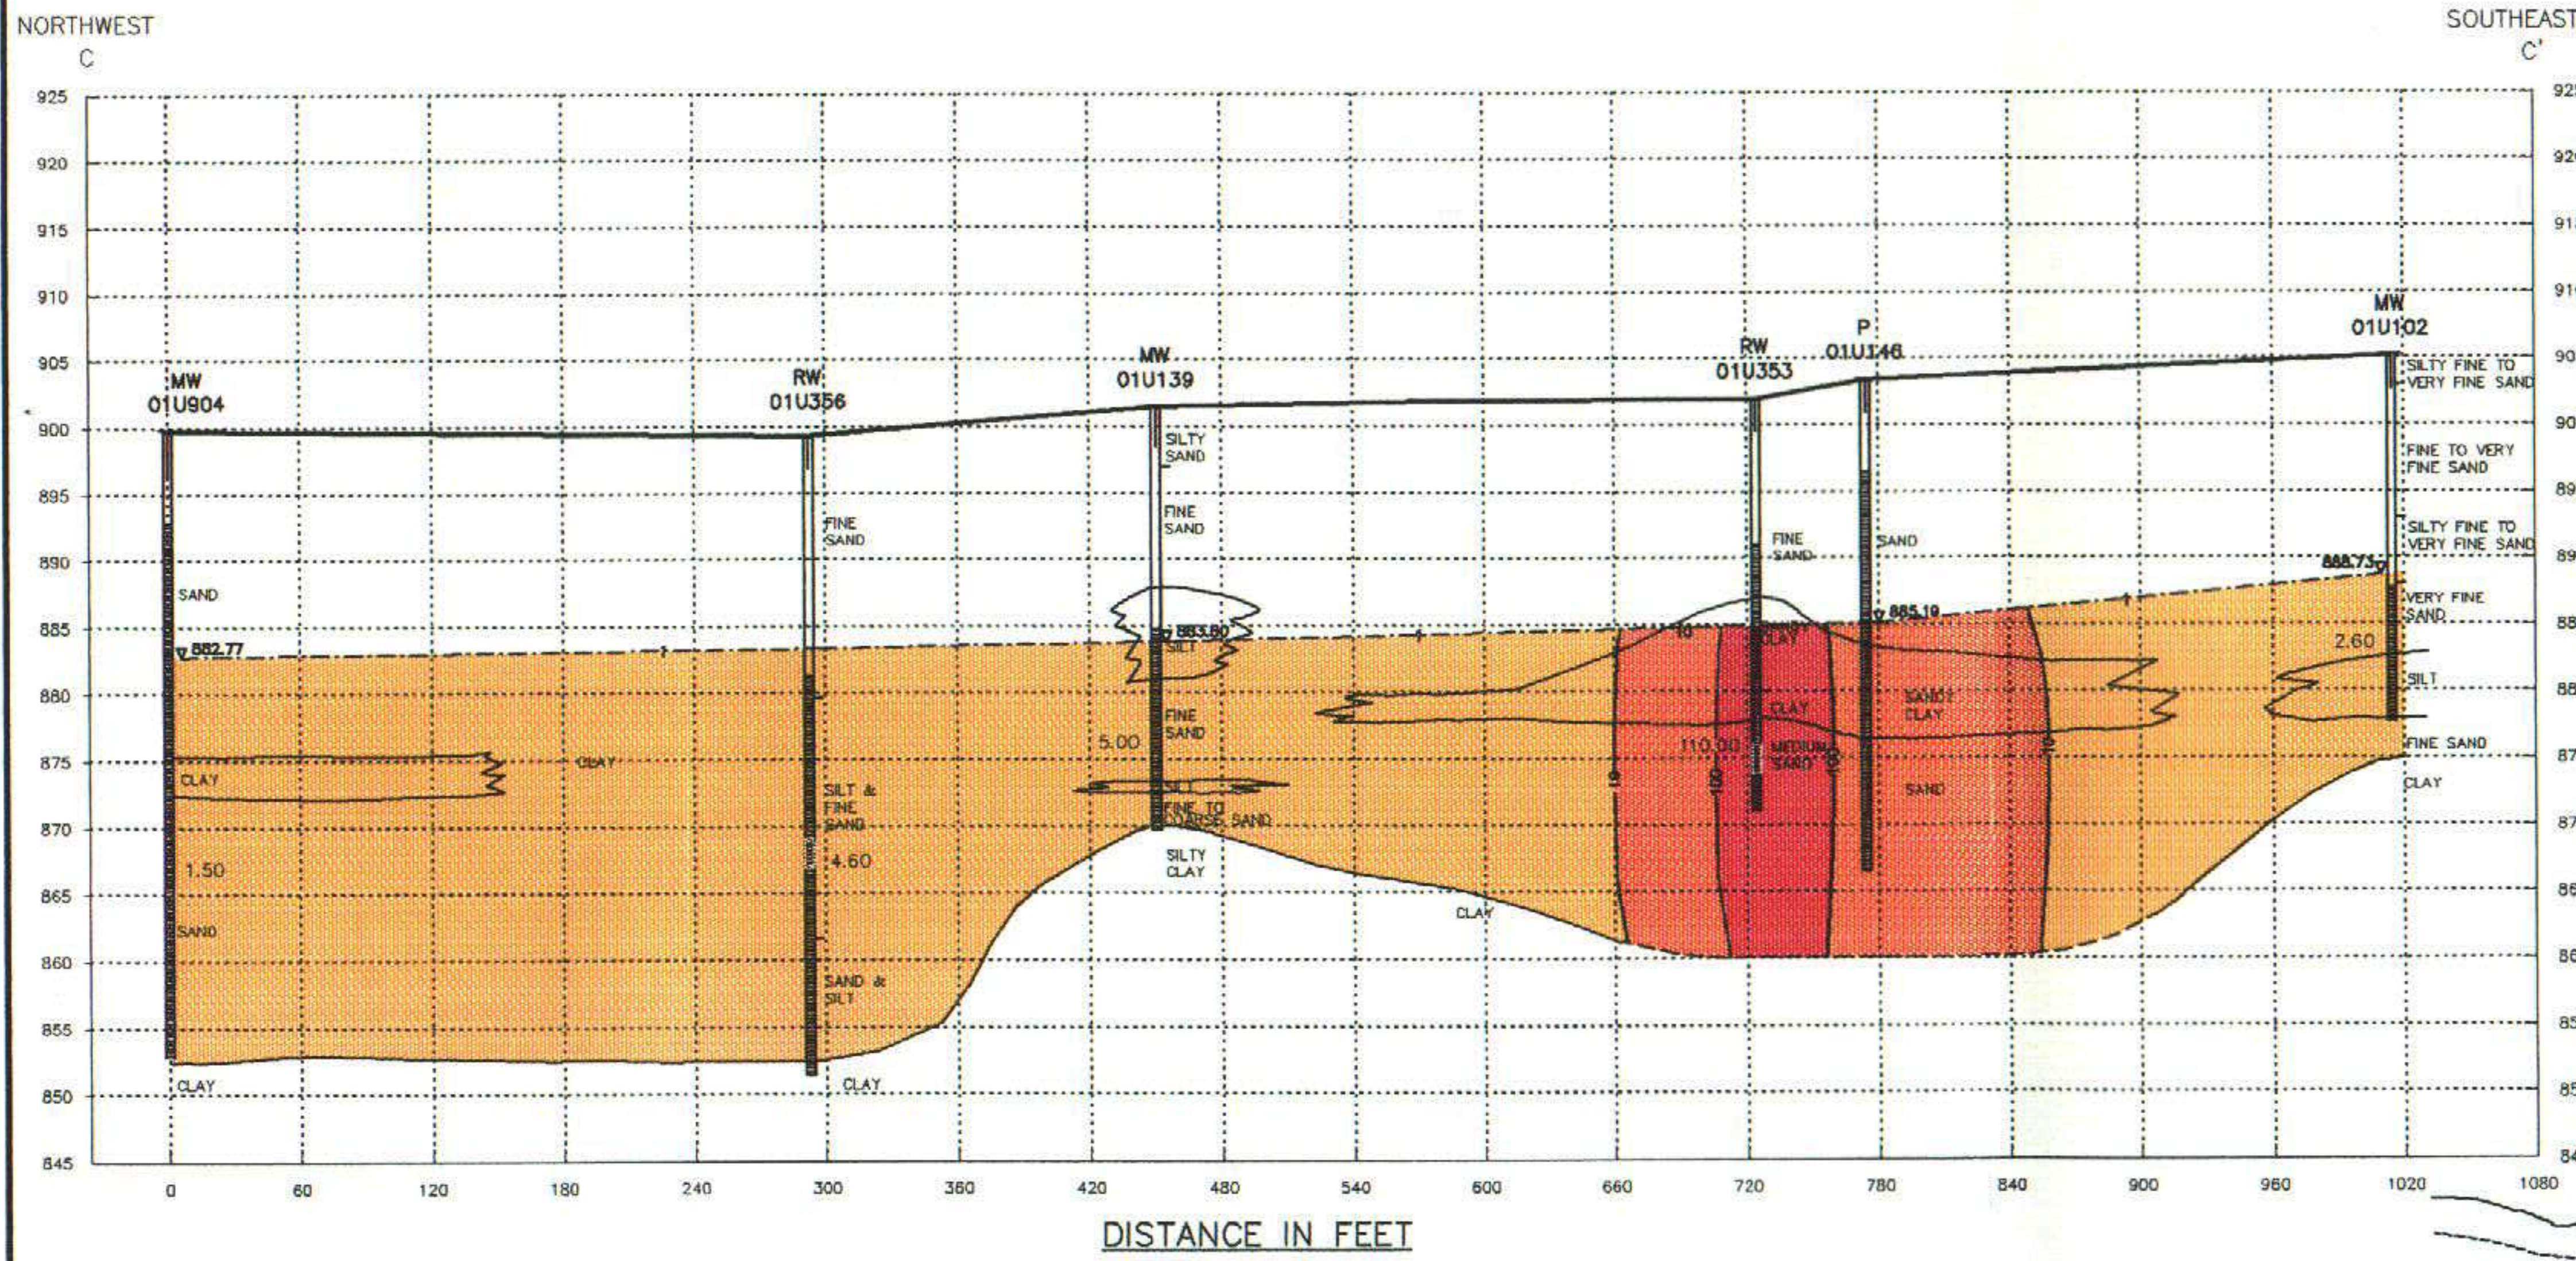
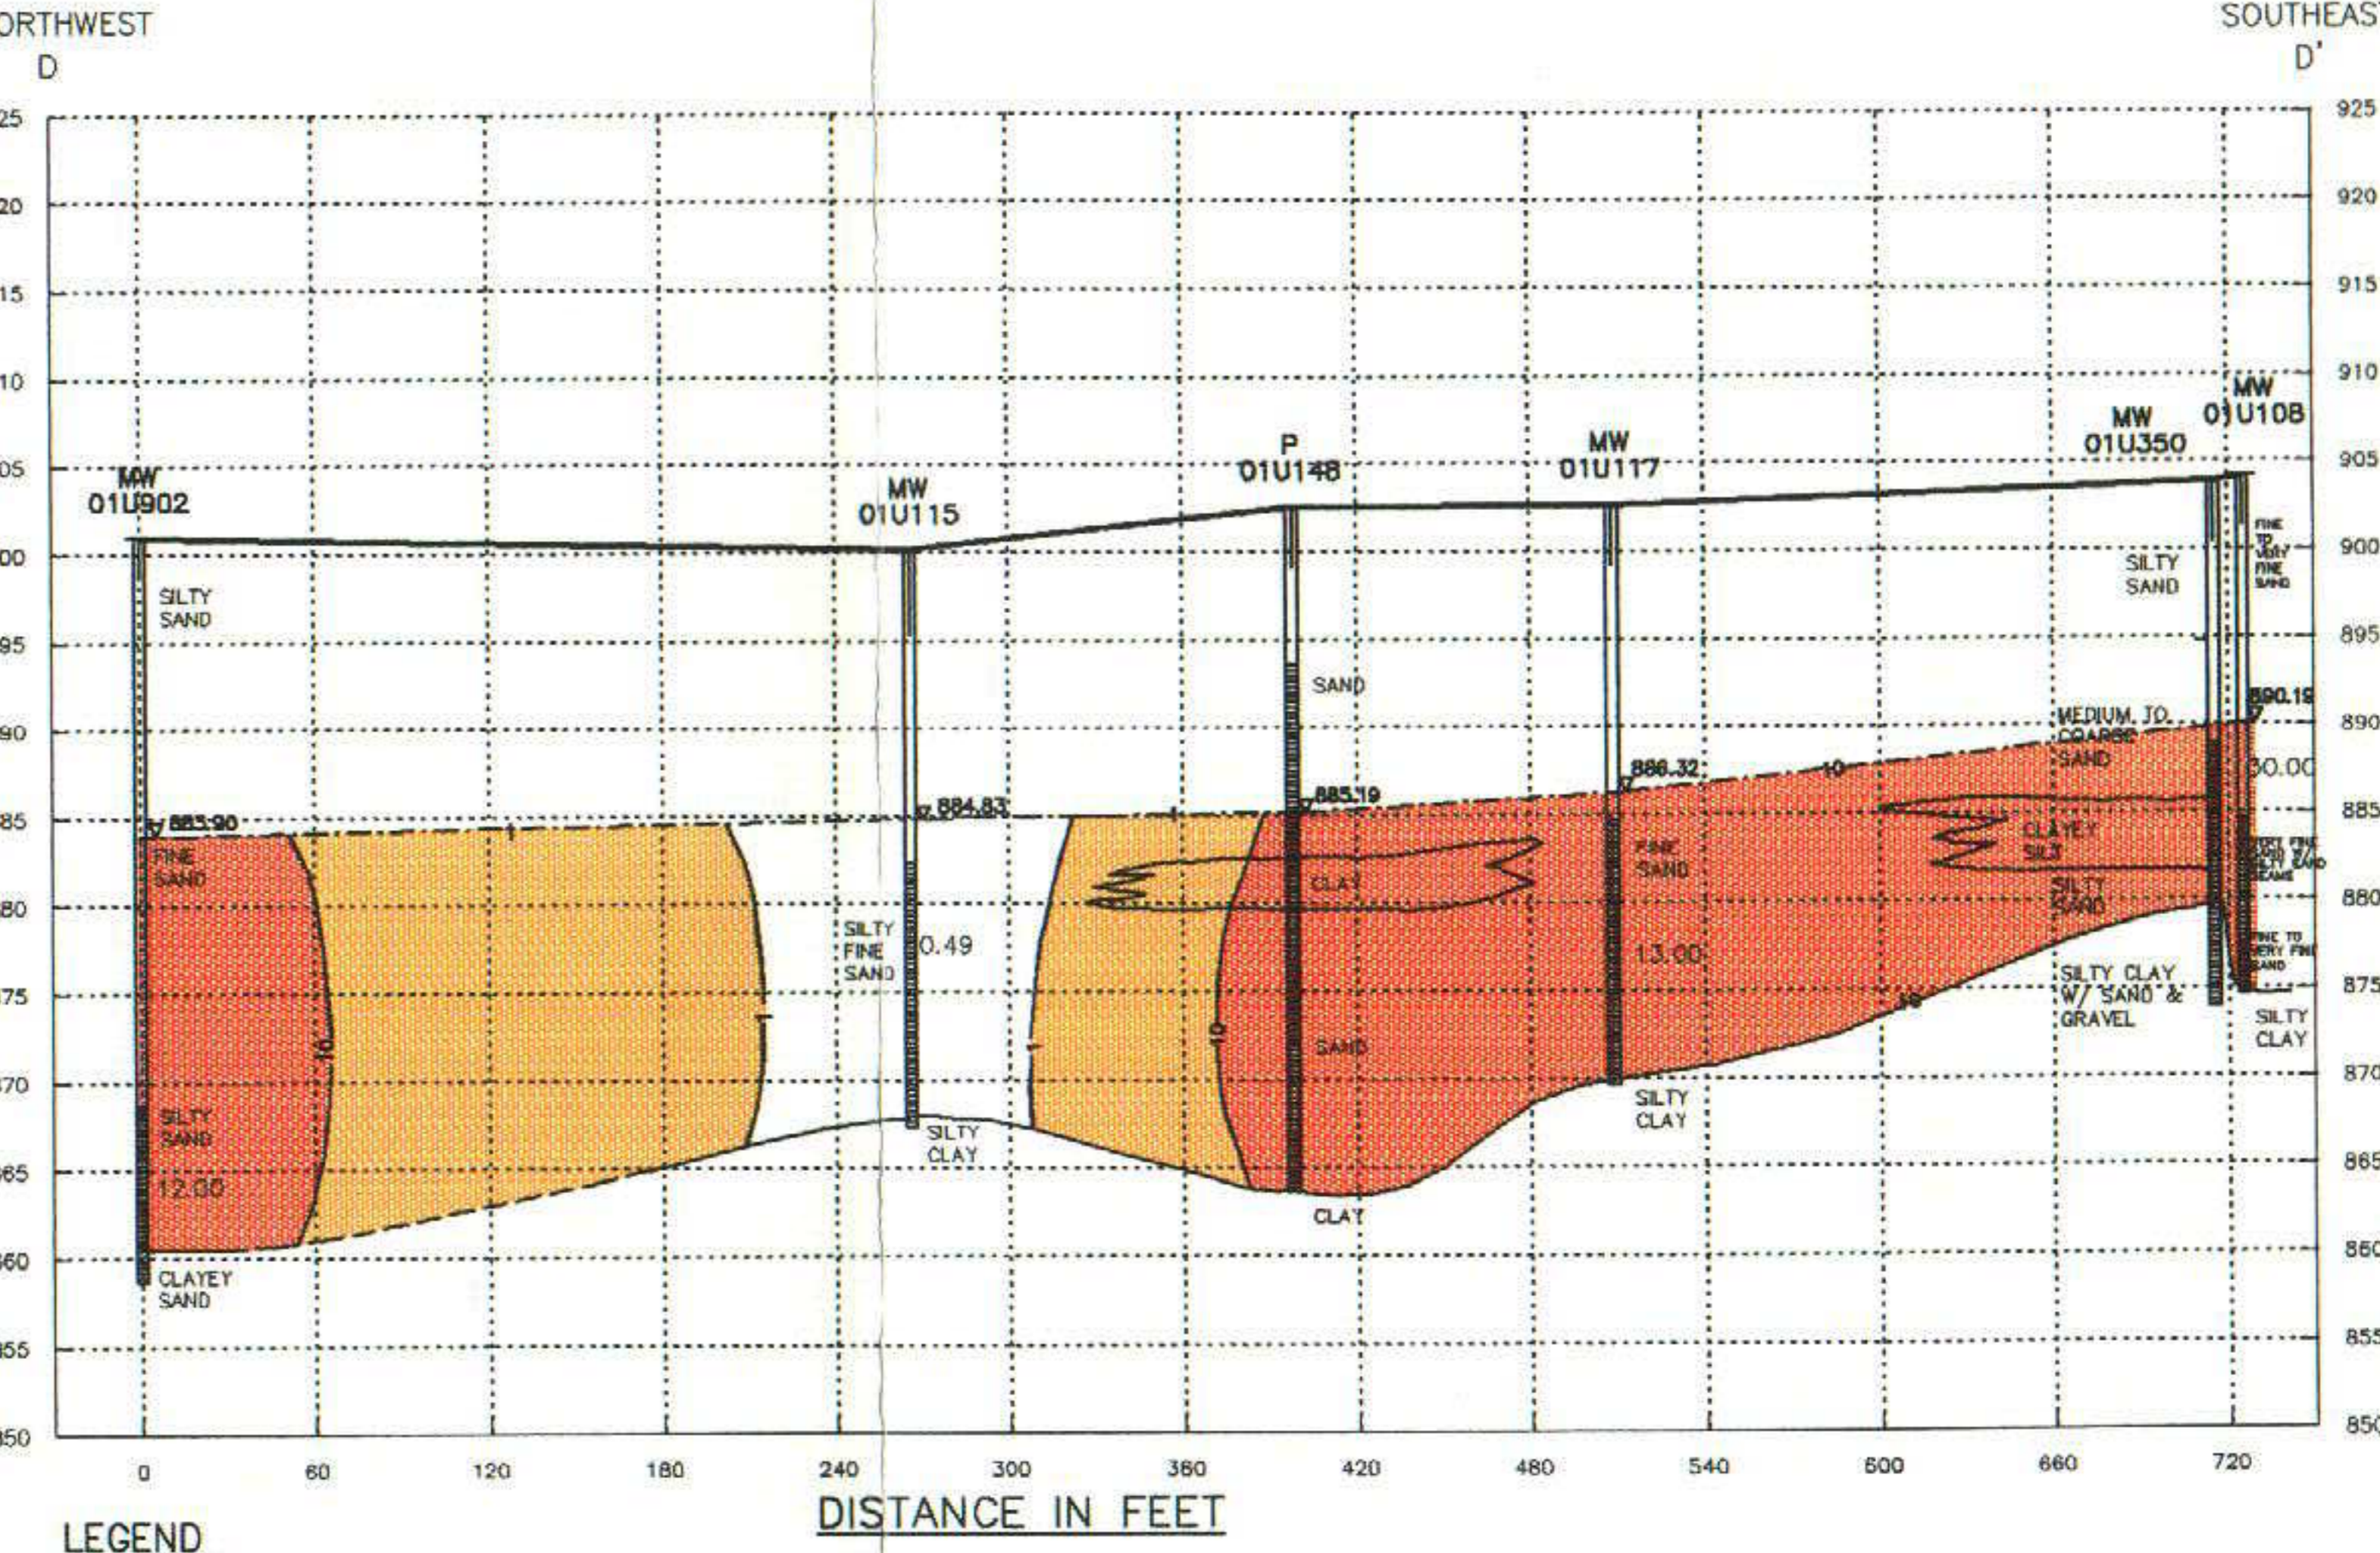
OCT 2000  
 Figure 6-2

view on Figure 6-2. The one partially penetrating well, 01U353, was completed in silt to sandy clay units which were resistant to drilling and determined to be the top of Unit 2 by the field geologist. The well log does not note the presence of silt (Fuller, 1994). The partially penetrating well is illustrated on cross-section B-B' on Figure 6-2.
