**INSTALLATION RESTORATION PROGRAM  
TWIN CITIES ARMY AMMUNITION PLANT**

**FISCAL YEAR 1999 ANNUAL PERFORMANCE REPORT**

**OCTOBER 2000  
FINAL REPORT**

Subject: Consistency Test for the Fiscal Year 1999 Annual Performance Report, Twin Cities Army Ammunition Plant, Arden Hills, Minnesota

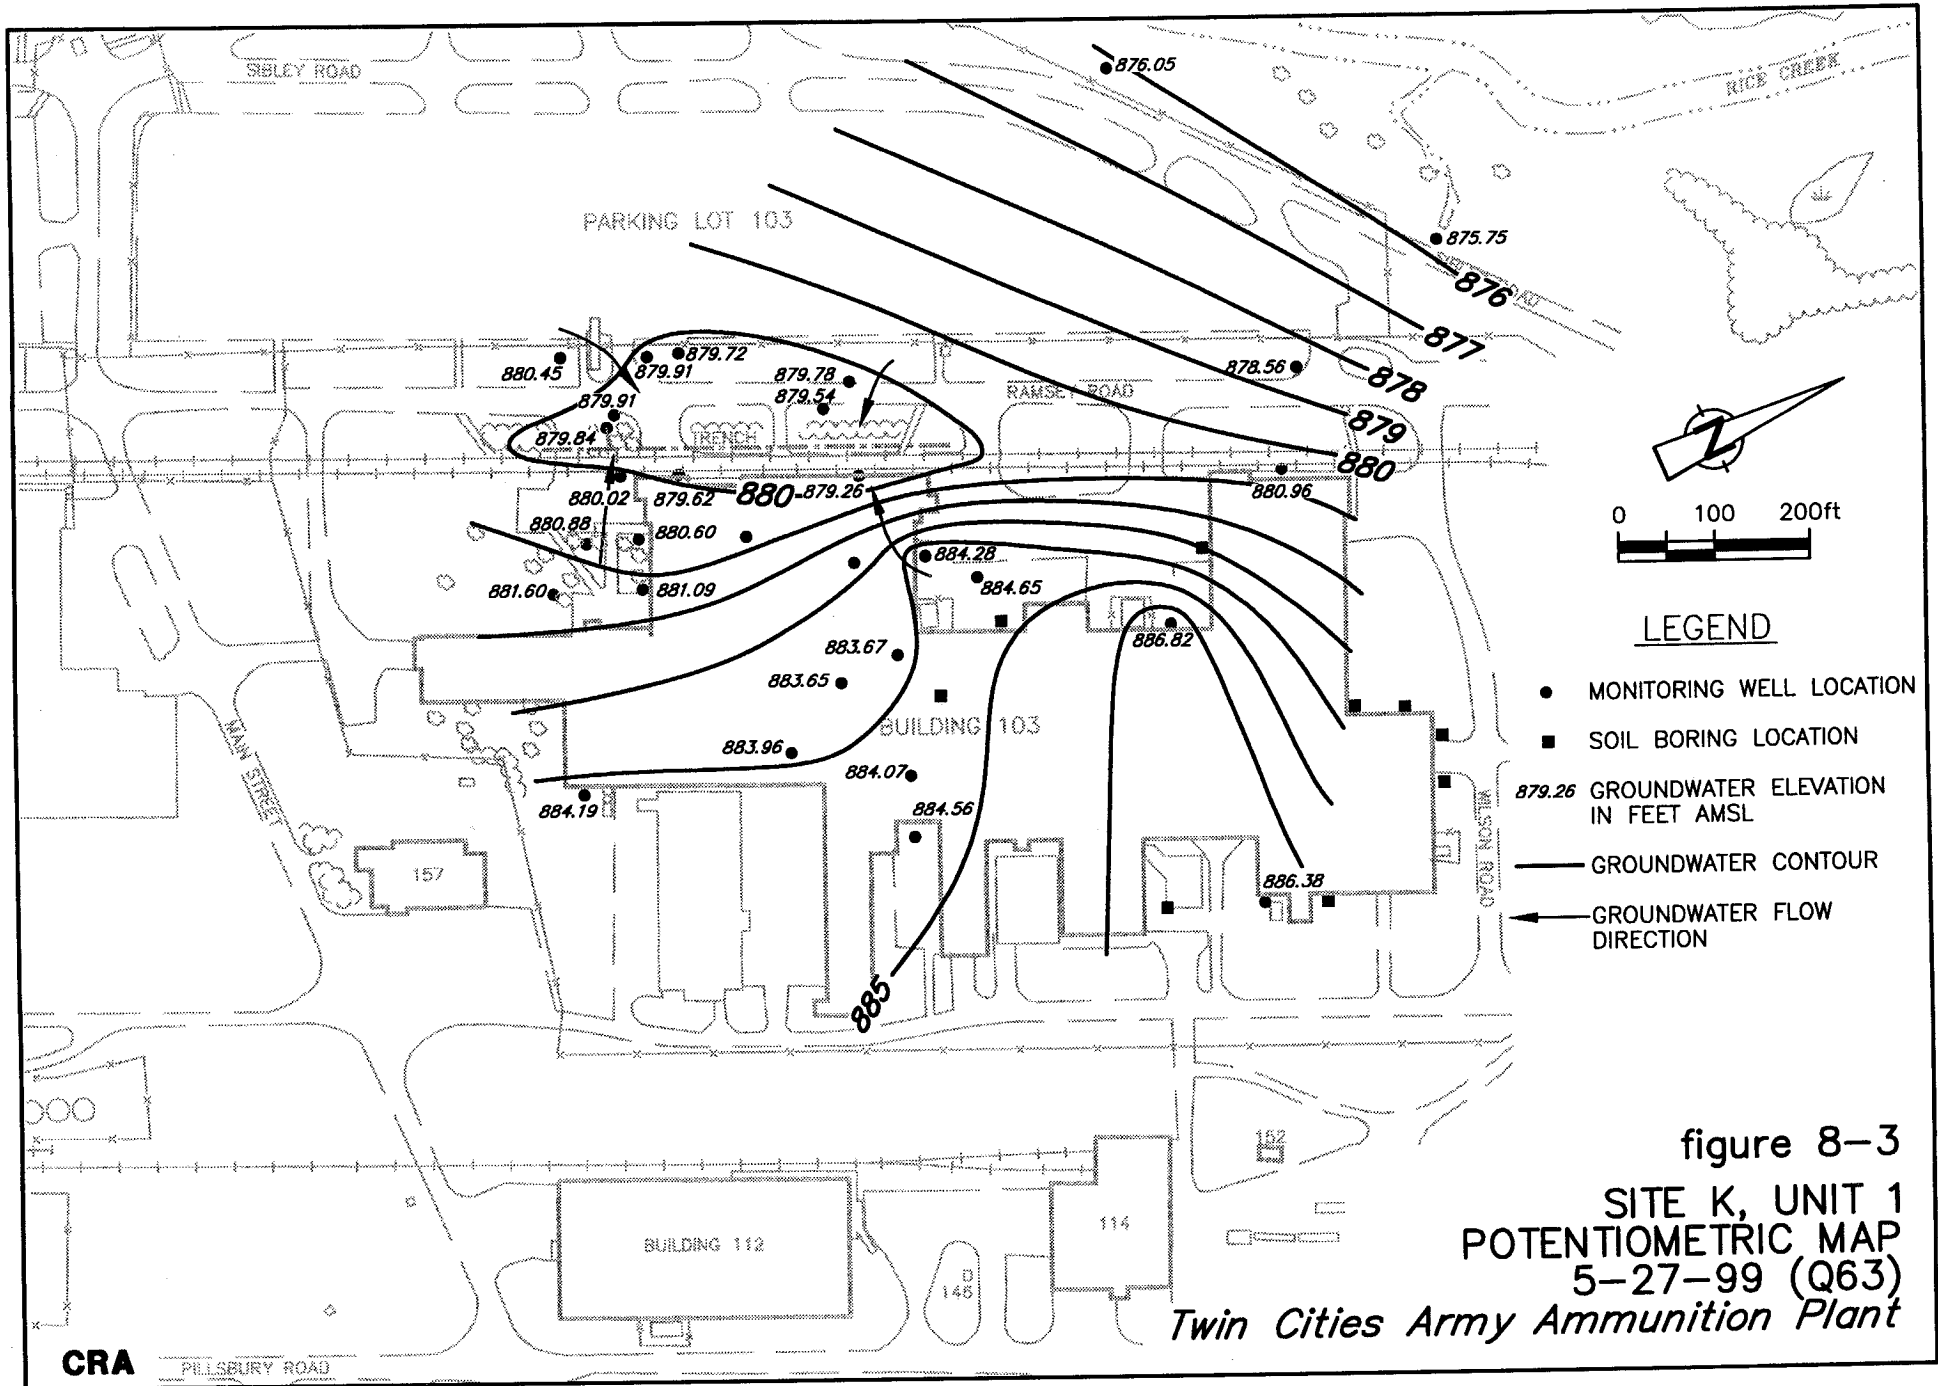
figure 8-3  
 SITE K, UNIT 1  
 POTENTIOMETRIC MAP  
 5-27-99 (Q63)  
 Twin Cities Army Ammunition Plant

Yes. Water level data are presented in Table 8-1. Figure 8-3 presents a plan view of the groundwater contours from the May round of groundwater level measurement. At nested wells, the lowest water elevation was used to create the plan view contours. Monitoring wells downgradient of the extraction trench show consistently higher water levels than those near and upgradient of the trench. This demonstrates that the horizontal hydraulic gradient has been reversed toward the extraction trench due to system operation.

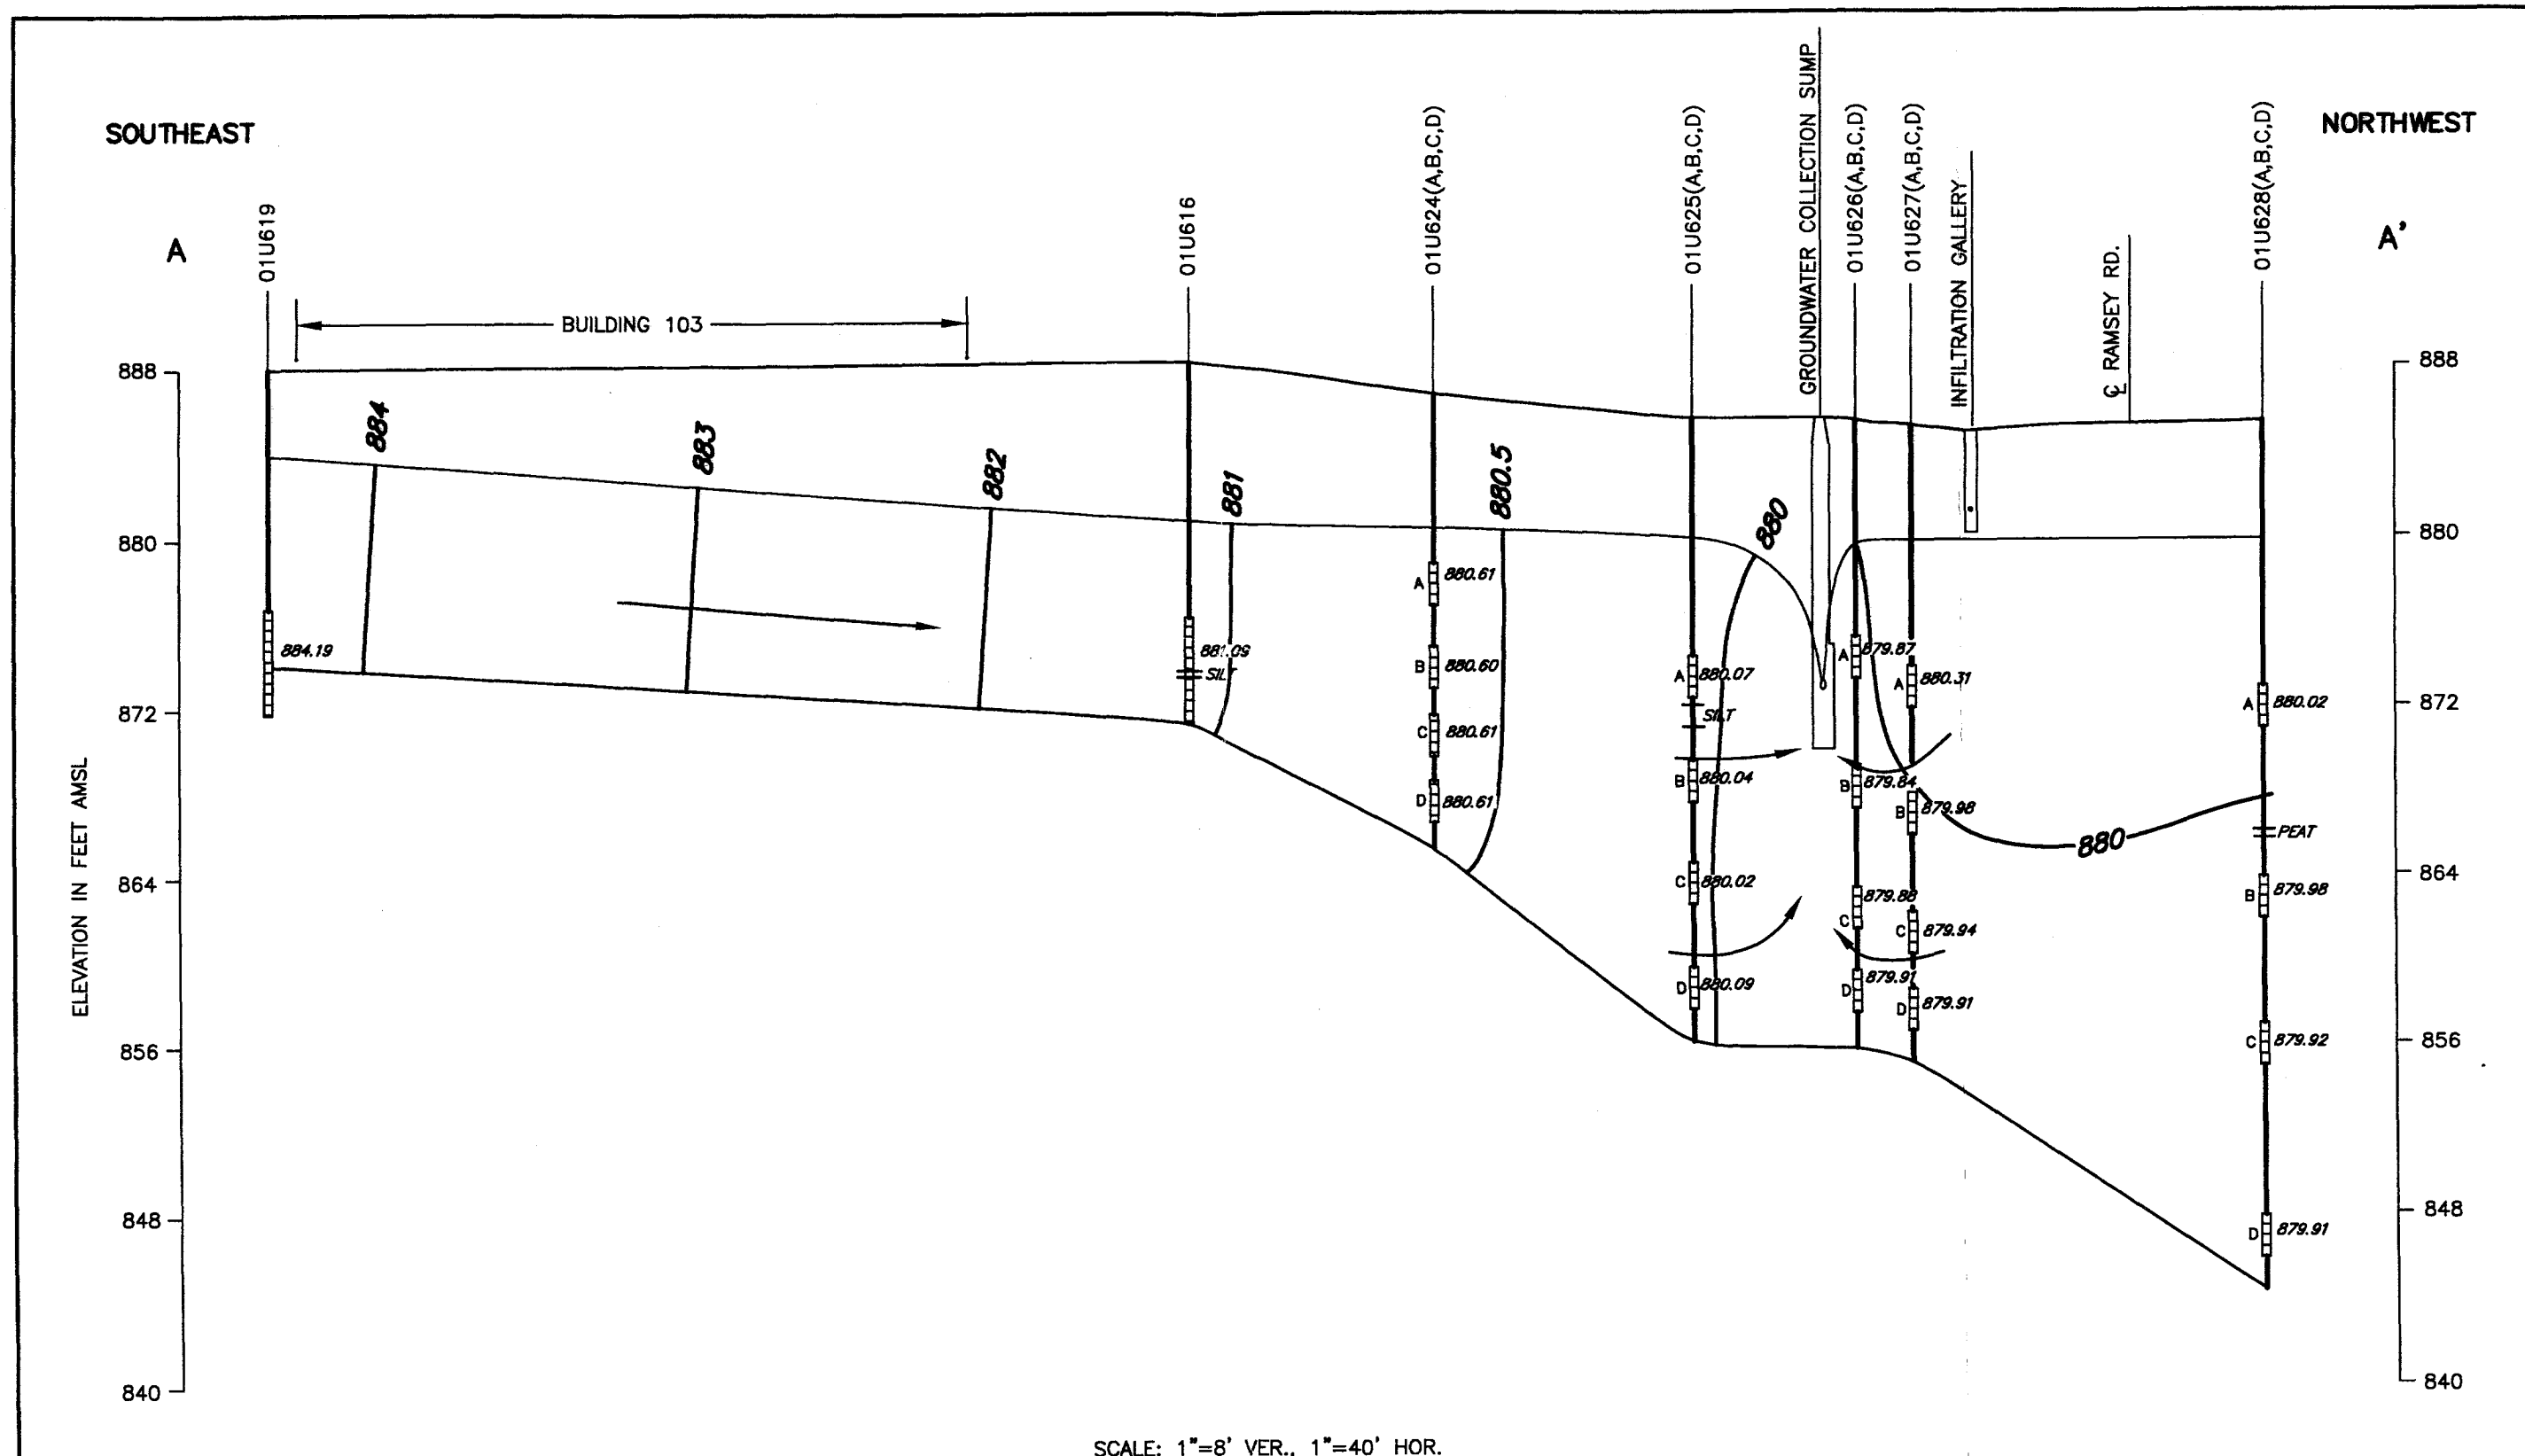
figure 8-4  
 SITE K, HYDROGEOLOGIC CROSS SECTION A-A'  
 5-27-99 (Q63)  
 Twin Cities Army Ammunition Plant

Vertical capture was also effective as illustrated on Figure 8-4. As seen in the figure, groundwater both upgradient and downgradient of the trench is captured and collected. The

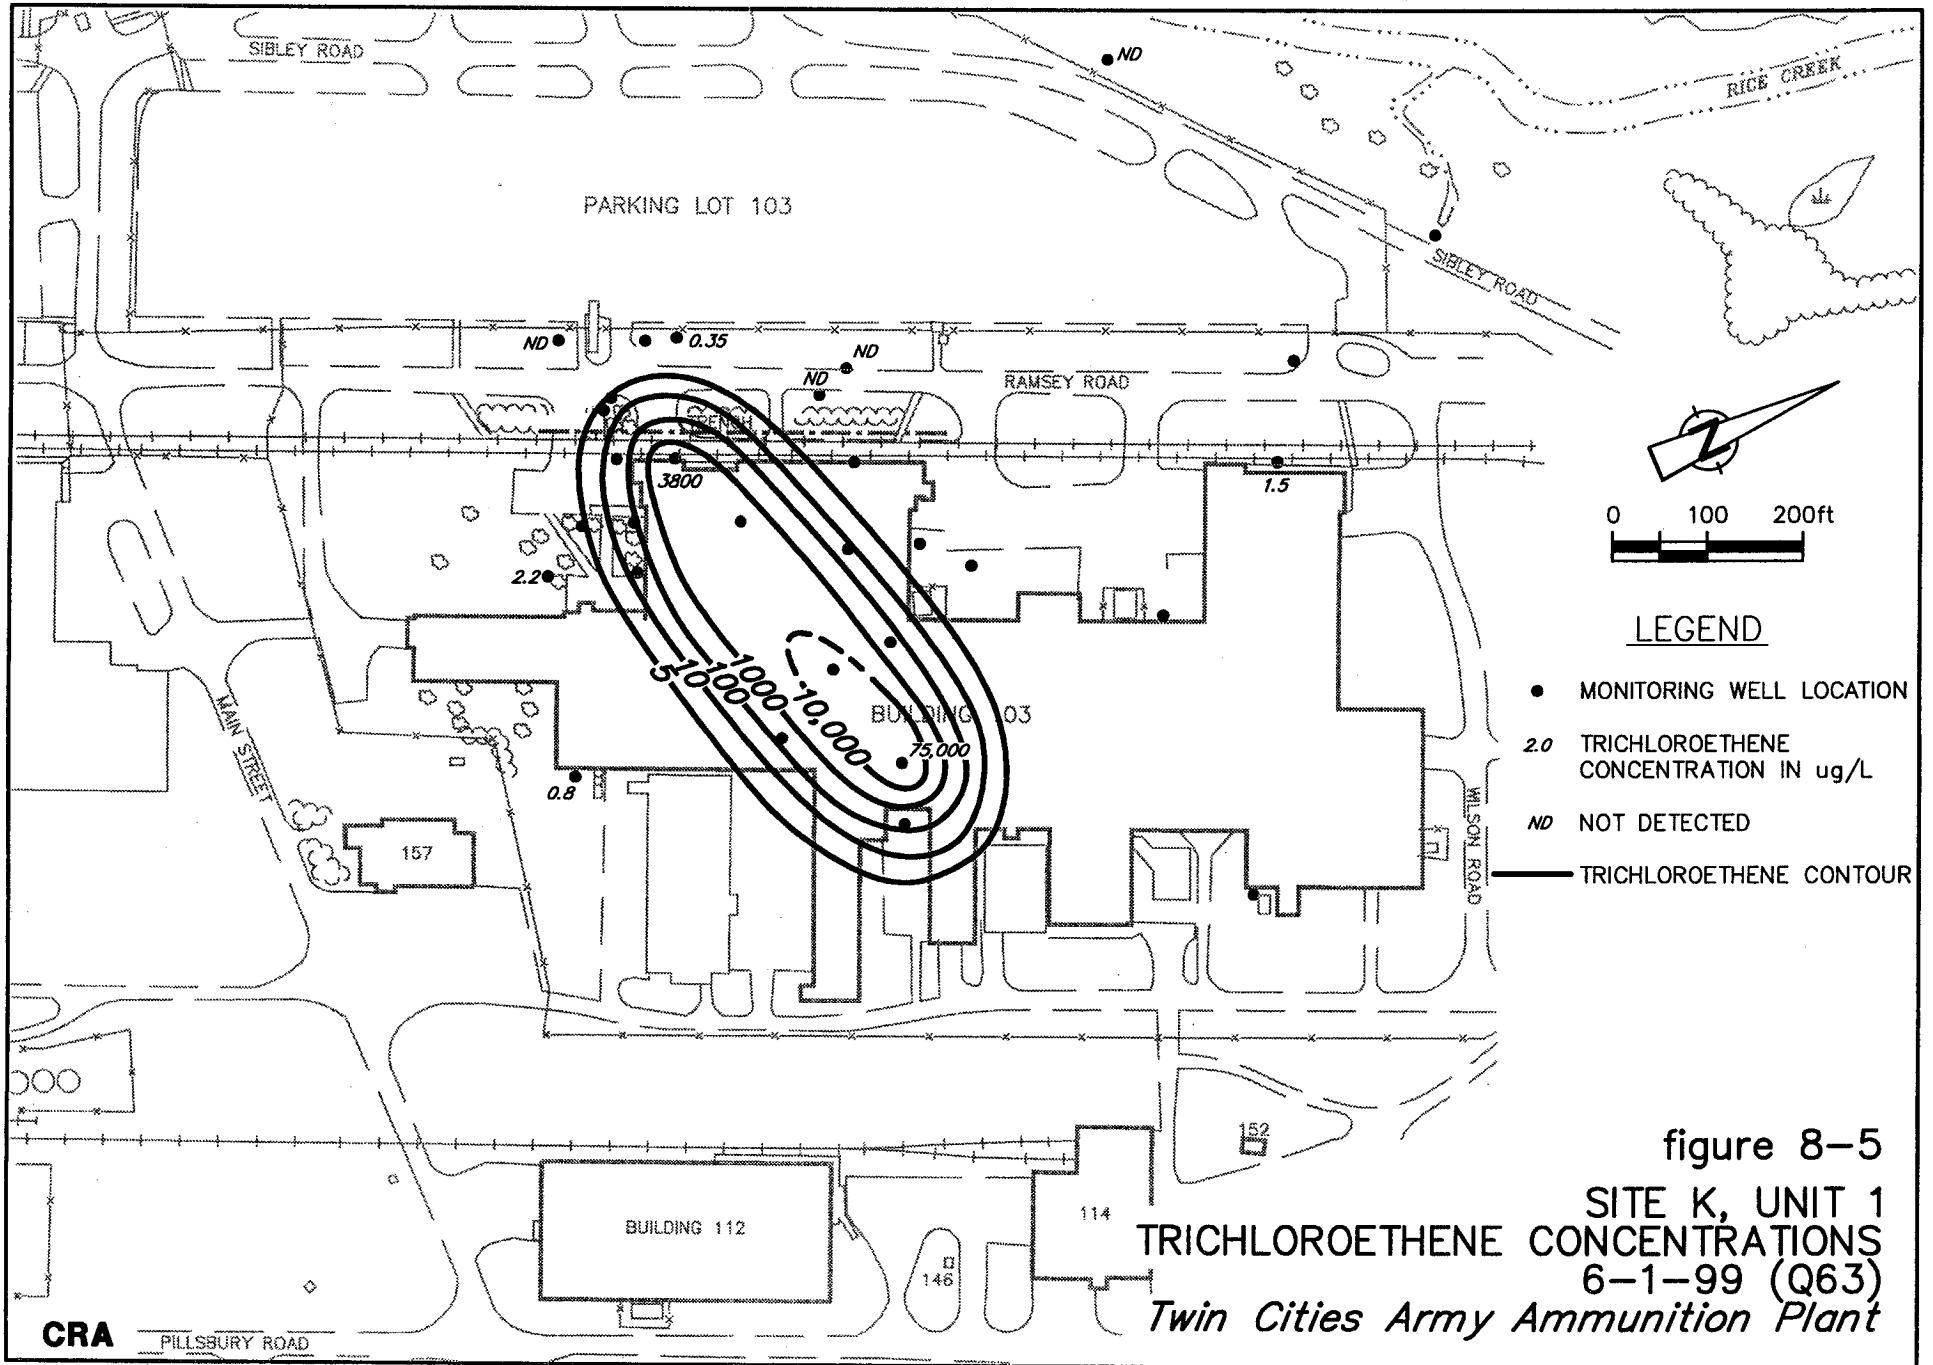
figure 8-5  
 SITE K, UNIT 1  
 TRICHLOROETHENE CONCENTRATIONS  
 6-1-99 (Q63)  
 Twin Cities Army Ammunition Plant

Figure 8-5 presents the trichloroethene concentrations from the June 1999 annual sampling event. Trichloroethene concentrations range from non-detect to 75,000  $\mu\text{g}/\text{l}$ . Comparison of Figure 8-5 to the groundwater contour maps indicates that the VOC plume is hydraulically contained by the treatment system. Table 8-2 presents the monitoring well sampling data. The plume was originally defined based on data from all of the monitoring wells. The current monitoring well network is used to confirm the plume contours and measure the progress of remediation. Thus, Figure 8-5 was drawn with consideration of the extensive historical data.

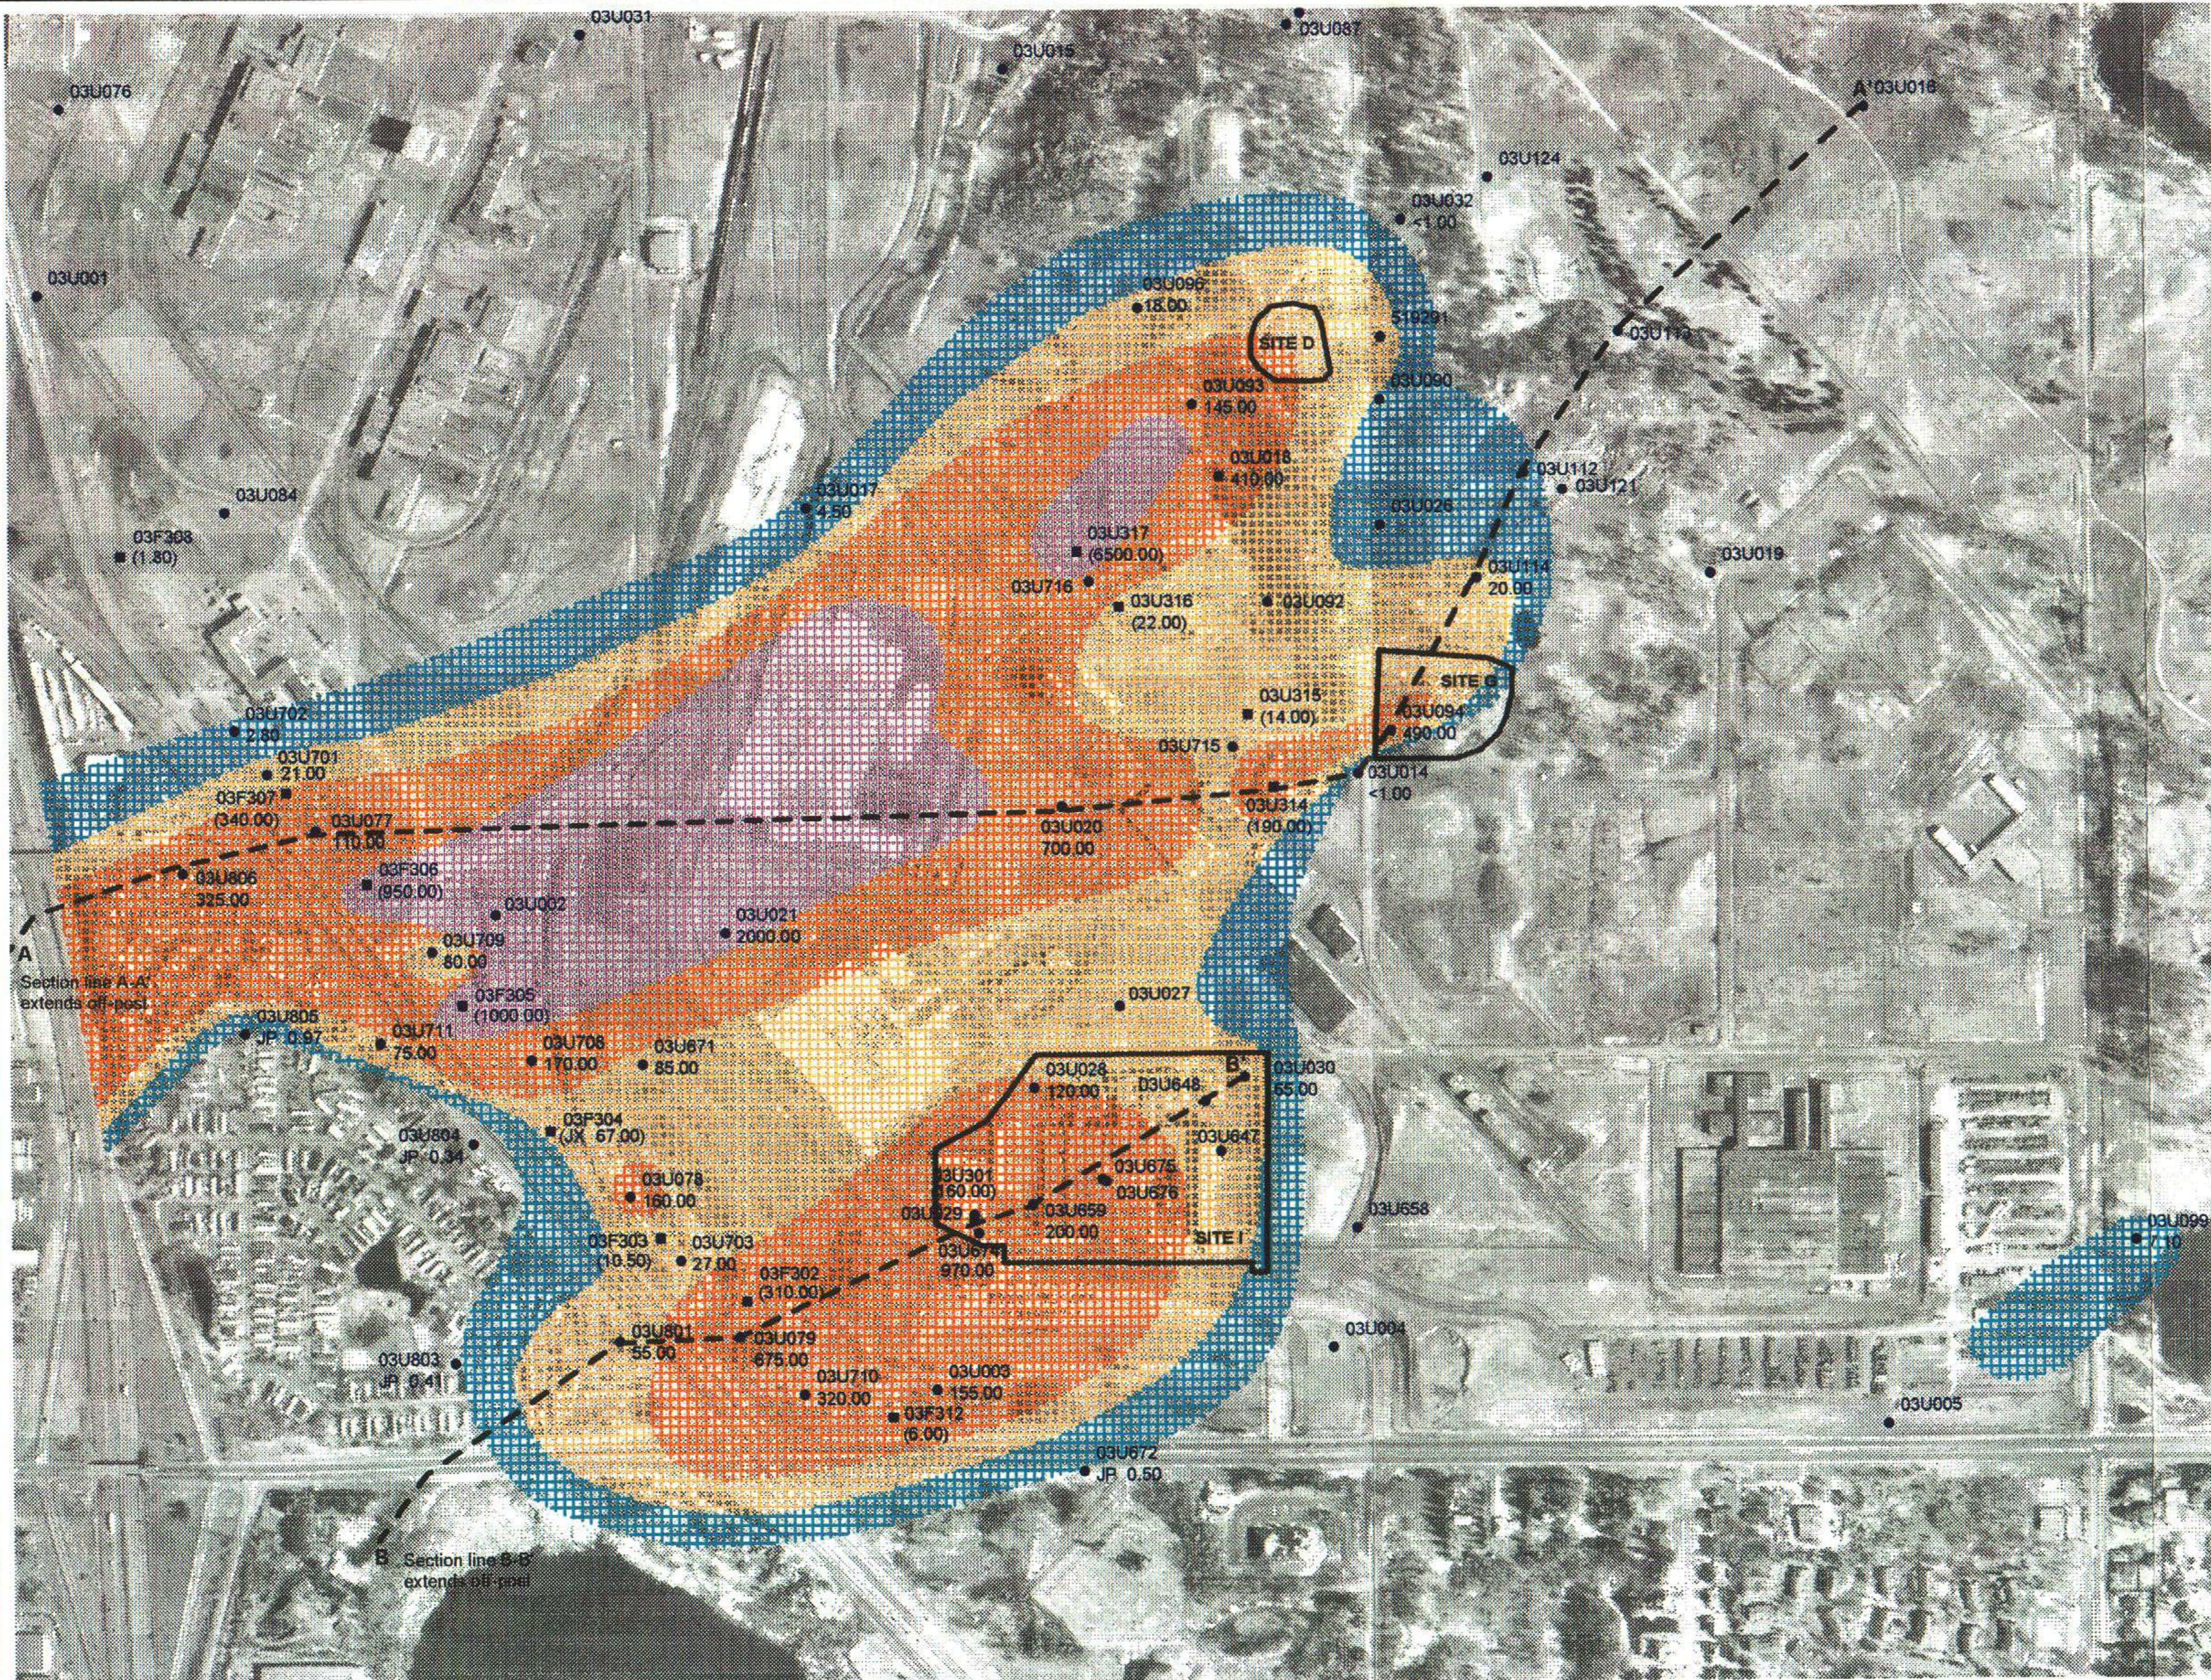
OCT 2000  
 Figure 9-5

Table 9-6 presents the groundwater quality data for FY 1999. Figure 9-5, Figure 9-6 and Figure 9-7 present the trichloroethene contours for the Upper Unit 3, Lower Unit 3, and Upper Unit 4 Aquifers, respectively. Along the TCAAP boundary, the width of the source area above 5  $\mu\text{g}/\text{l}$  trichloroethene has been shrinking since approximately 1993. Currently, there are no Unit 3 wells north of B7 above 5  $\mu\text{g}/\text{l}$  trichloroethene. In Unit 4, there were no monitoring wells north of B10 above 5  $\mu\text{g}/\text{l}$ . Extraction well B12 was shut down in November 1996 in response to the observed reduction in the extent of source area contamination. These declining VOC concentrations show that the TGRS has successfully reduced the source area contaminant concentration in this portion of the site.

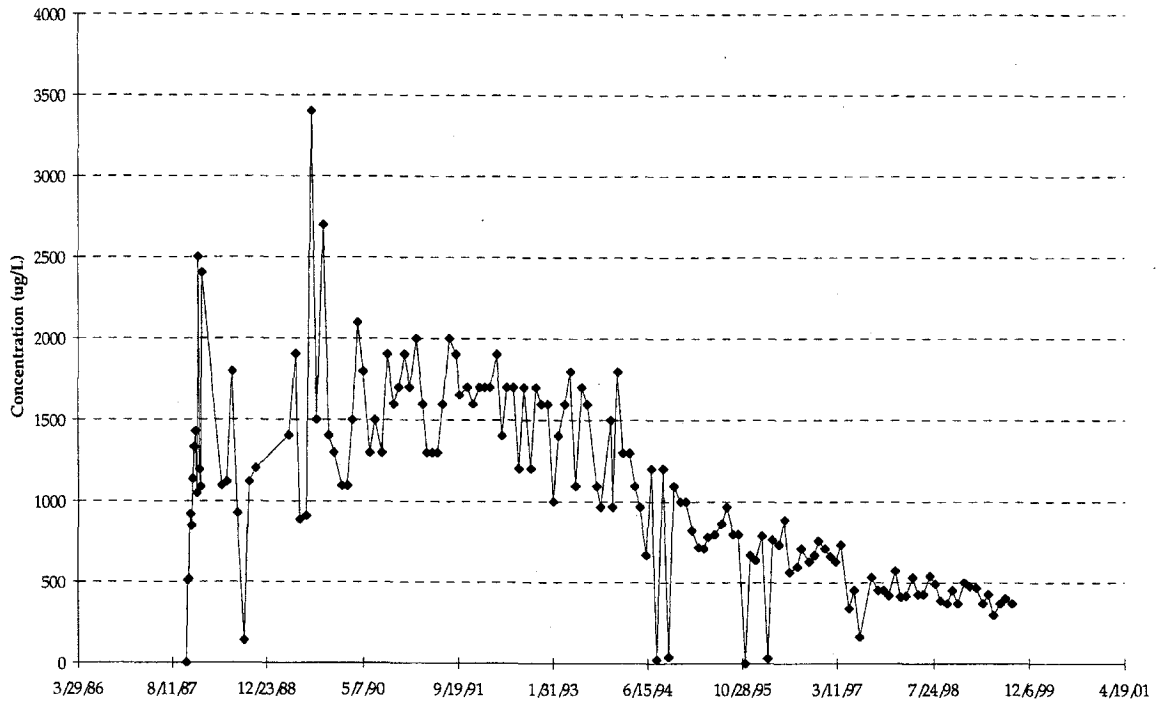
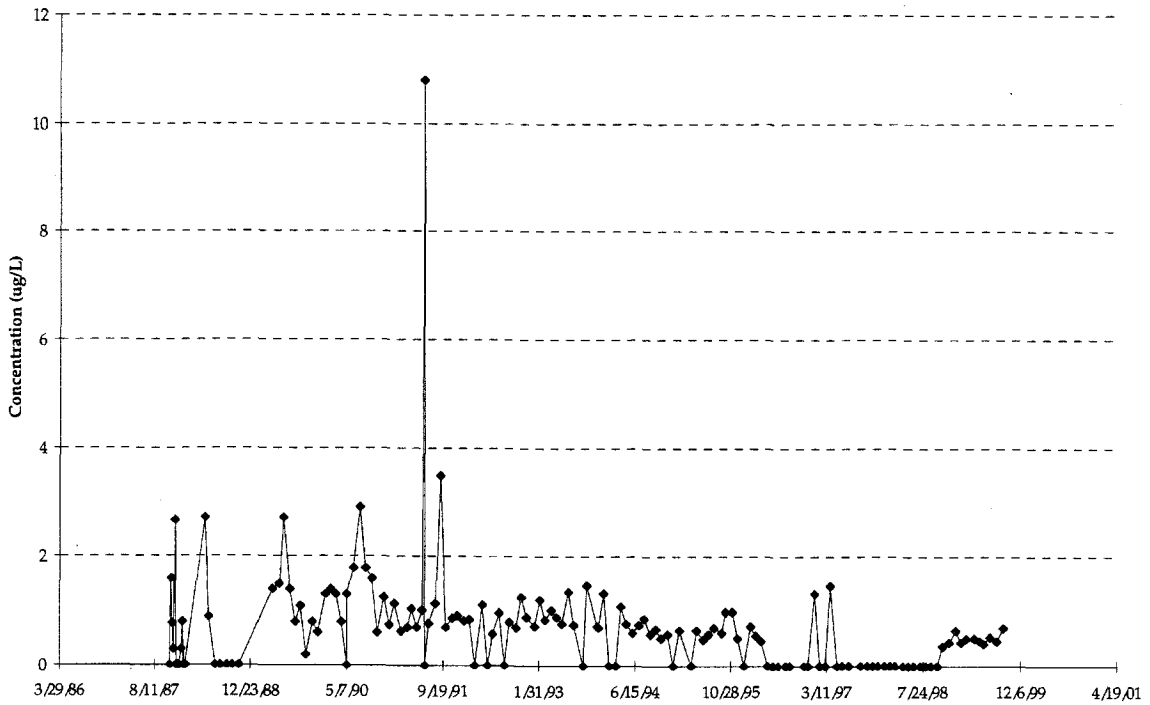
figure 9-8

Yes. Influent and effluent water were sampled on a monthly basis during FY 1999. The influent/effluent database for FY 1999 is contained in Appendix I.2. TGRS influent is labeled TGRSI and effluent is labeled TGRSE. Figure 9-8 presents a graph of influent trichloroethene versus time. This graph is cumulative and includes data from before 1989, when the system consisted of only six extraction wells. Influent concentrations continued to decline in FY 1999.

Figure 9-8 also includes a summary of the effluent trichloroethene concentration versus time. As indicated, the effluent was below 5  $\mu\text{g}/\text{l}$  trichloroethene for all sampling events in FY 1999. A review of the FY 1999 database indicates that the effluent has also remained below the treatment requirements for all other VOC compounds specified in the OU2 ROD. Comparison of influent and effluent trichloroethene concentrations indicates an average removal efficiency over 99.9 percent.

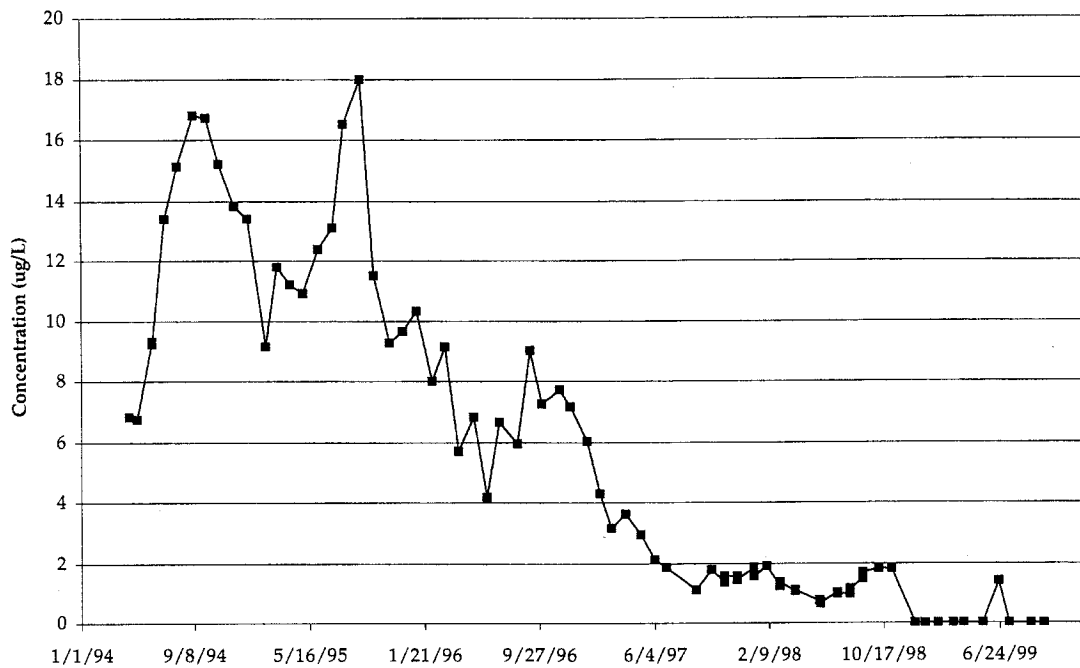
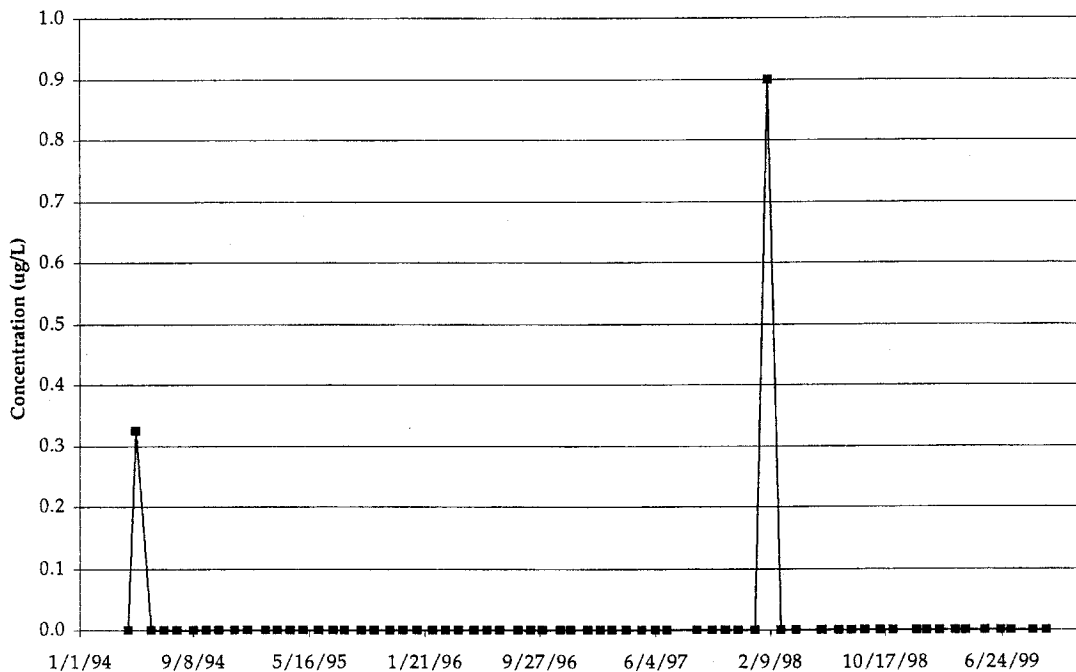
figure 10-2

Yes. Influent and effluent water was sampled on a monthly basis during FY 1999 and the results are provided in Table 10-2. PGRS influent is labeled NB13I and effluent is labeled NB13E. Table 10-3 presents a summary of monthly VOC removal for FY 1999 and Figure 10-2 shows the influent trichloroethene concentration versus time. The average FY 1999 influent trichloroethene concentration was  $<1.0 \mu\text{g/l}$ . Figure 10-2 indicates that influent concentrations continue to decrease. The influent to the treatment system ranged from  $<1 \mu\text{g/l}$  to  $1.8 \mu\text{g/l}$  trichloroethene in FY 1999.

Figure 10-2 also presents a summary of the effluent trichloroethene concentration versus time. As indicated, the effluent has remained below the contaminant-specific requirements for all VOC compounds. The presence of chloroform in the effluent is most likely due to chlorination in the treatment train as part of the iron removal system.
