Fiscal Year 2021 Annual Performance Report New Brighton/Arden Hills Superfund Site Twin Cities Army Ammunition Plant

EA Engineering, Science, and Technology, Inc.
5918 Meridian Boulevard, Suite 4
Brighton, Michigan 48116
(734) 369-3410

February 2023
Version: FINAL
EA Project No. 6327503

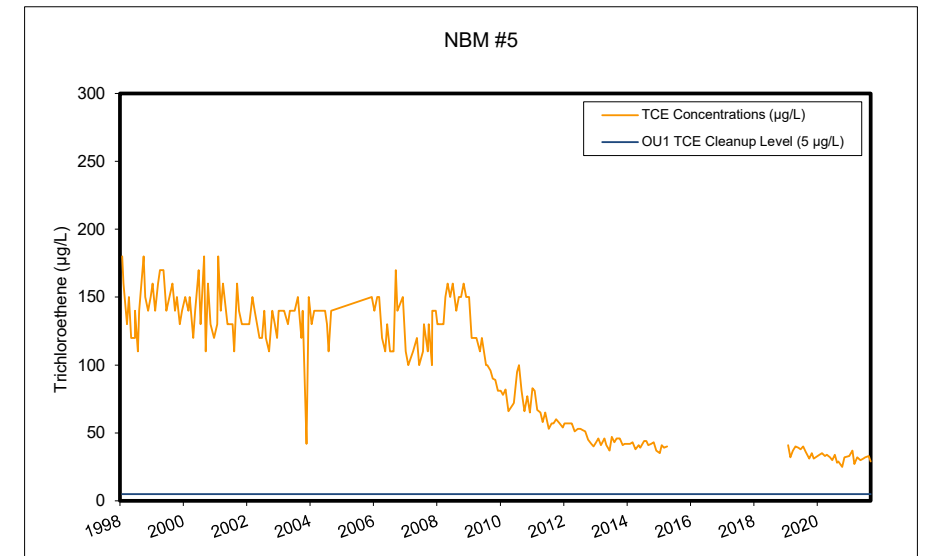
NEW BRIGHTON MUNICIPAL WELLS: TRICHLOROETHENE WATER QUALITY TRENDS

Note: Routine pumping of the NBCGRS was ceased on April 15, 2015, with notice to the USEPA/MPCA, due to detection of 1,4-dioxane in the Prairie du Chien and Jordan Aquifer municipal wells. Since the granular activated carbon (GAC) does not remove 1,4-dioxane, New Brighton is preferentially pumping deep aquifer wells that have no detectable 1,4-dioxane while the City evaluates the feasibility of 1,4-dioxane removal technologies. This has been referred to as a “Remedy Time-Out,” and normal pumping of the NBCGRS will not be resumed until a technology is selected and modification of the NBCGRS is designed and constructed. The Fridley Interconnection was also closed on April 15, 2015. Update: The routine pumping of the NBCGRS began again in 2019 following the implementation of a treatment system for 1,4-dioxane.

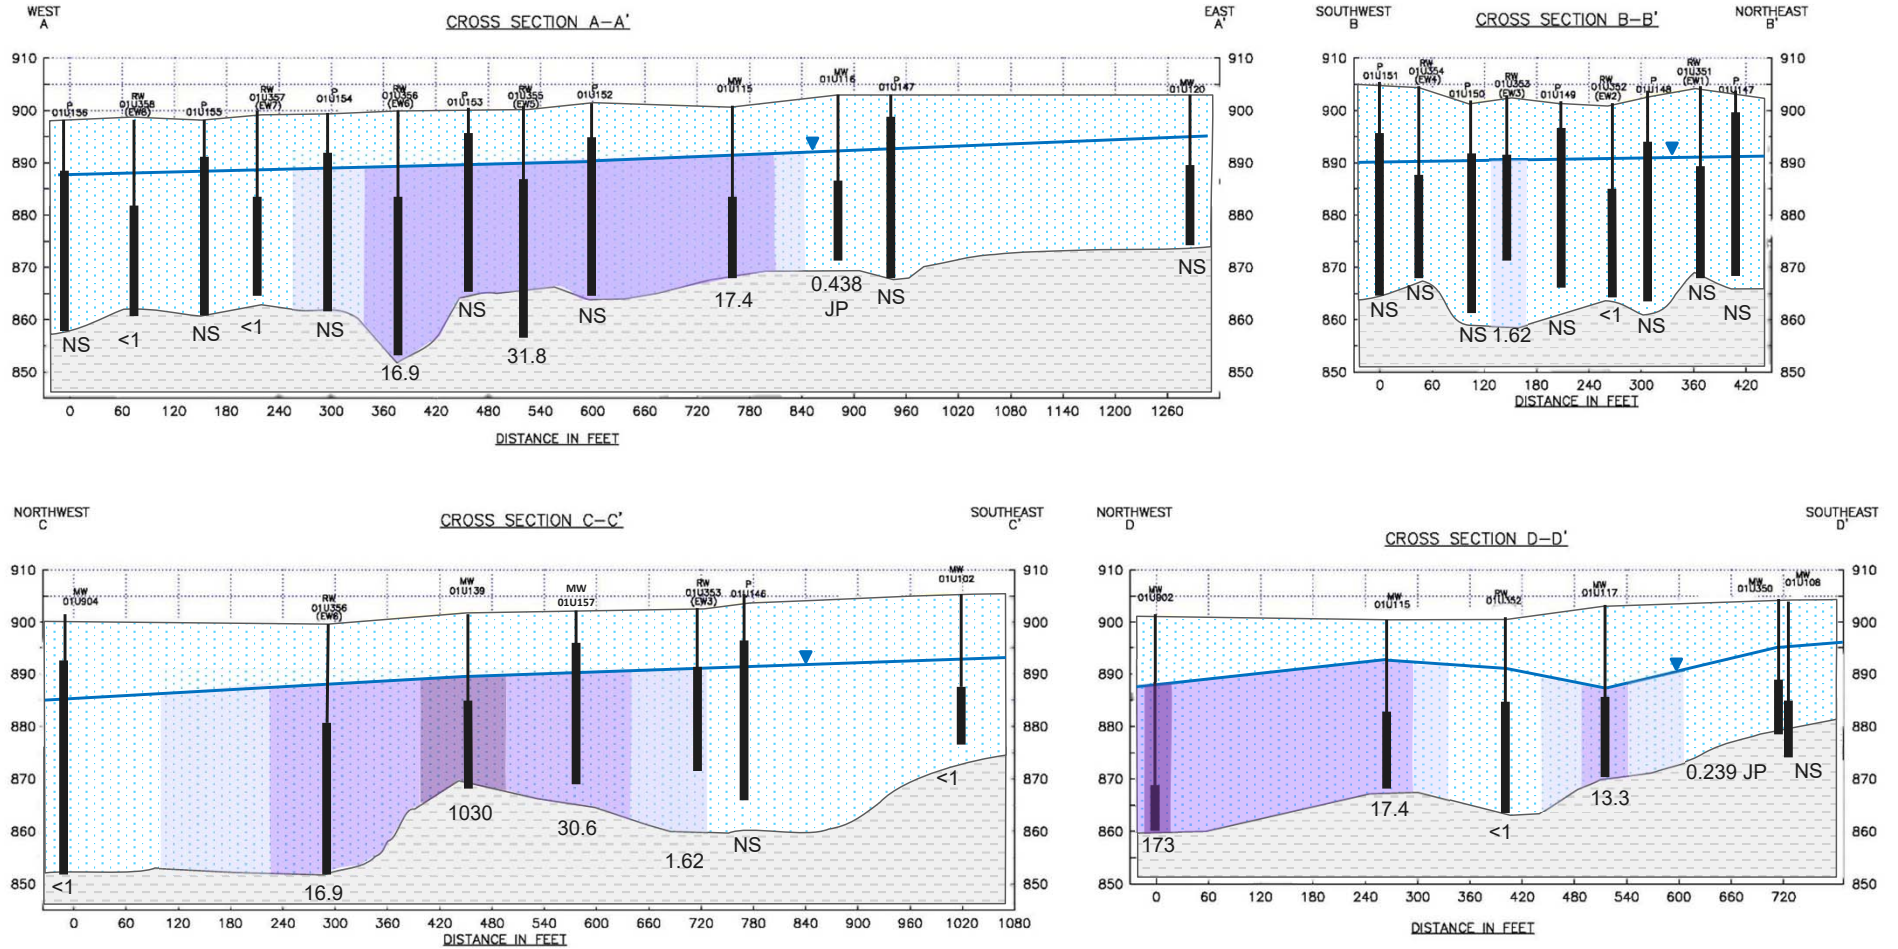
FY 2021 Annual Performance Report
Figure 5-6
Site A cis-1,2-Dichloroethene Cross Sections A, B, C, D

cis-1,2-Dichloroethene Plume Concentration (µg/L)

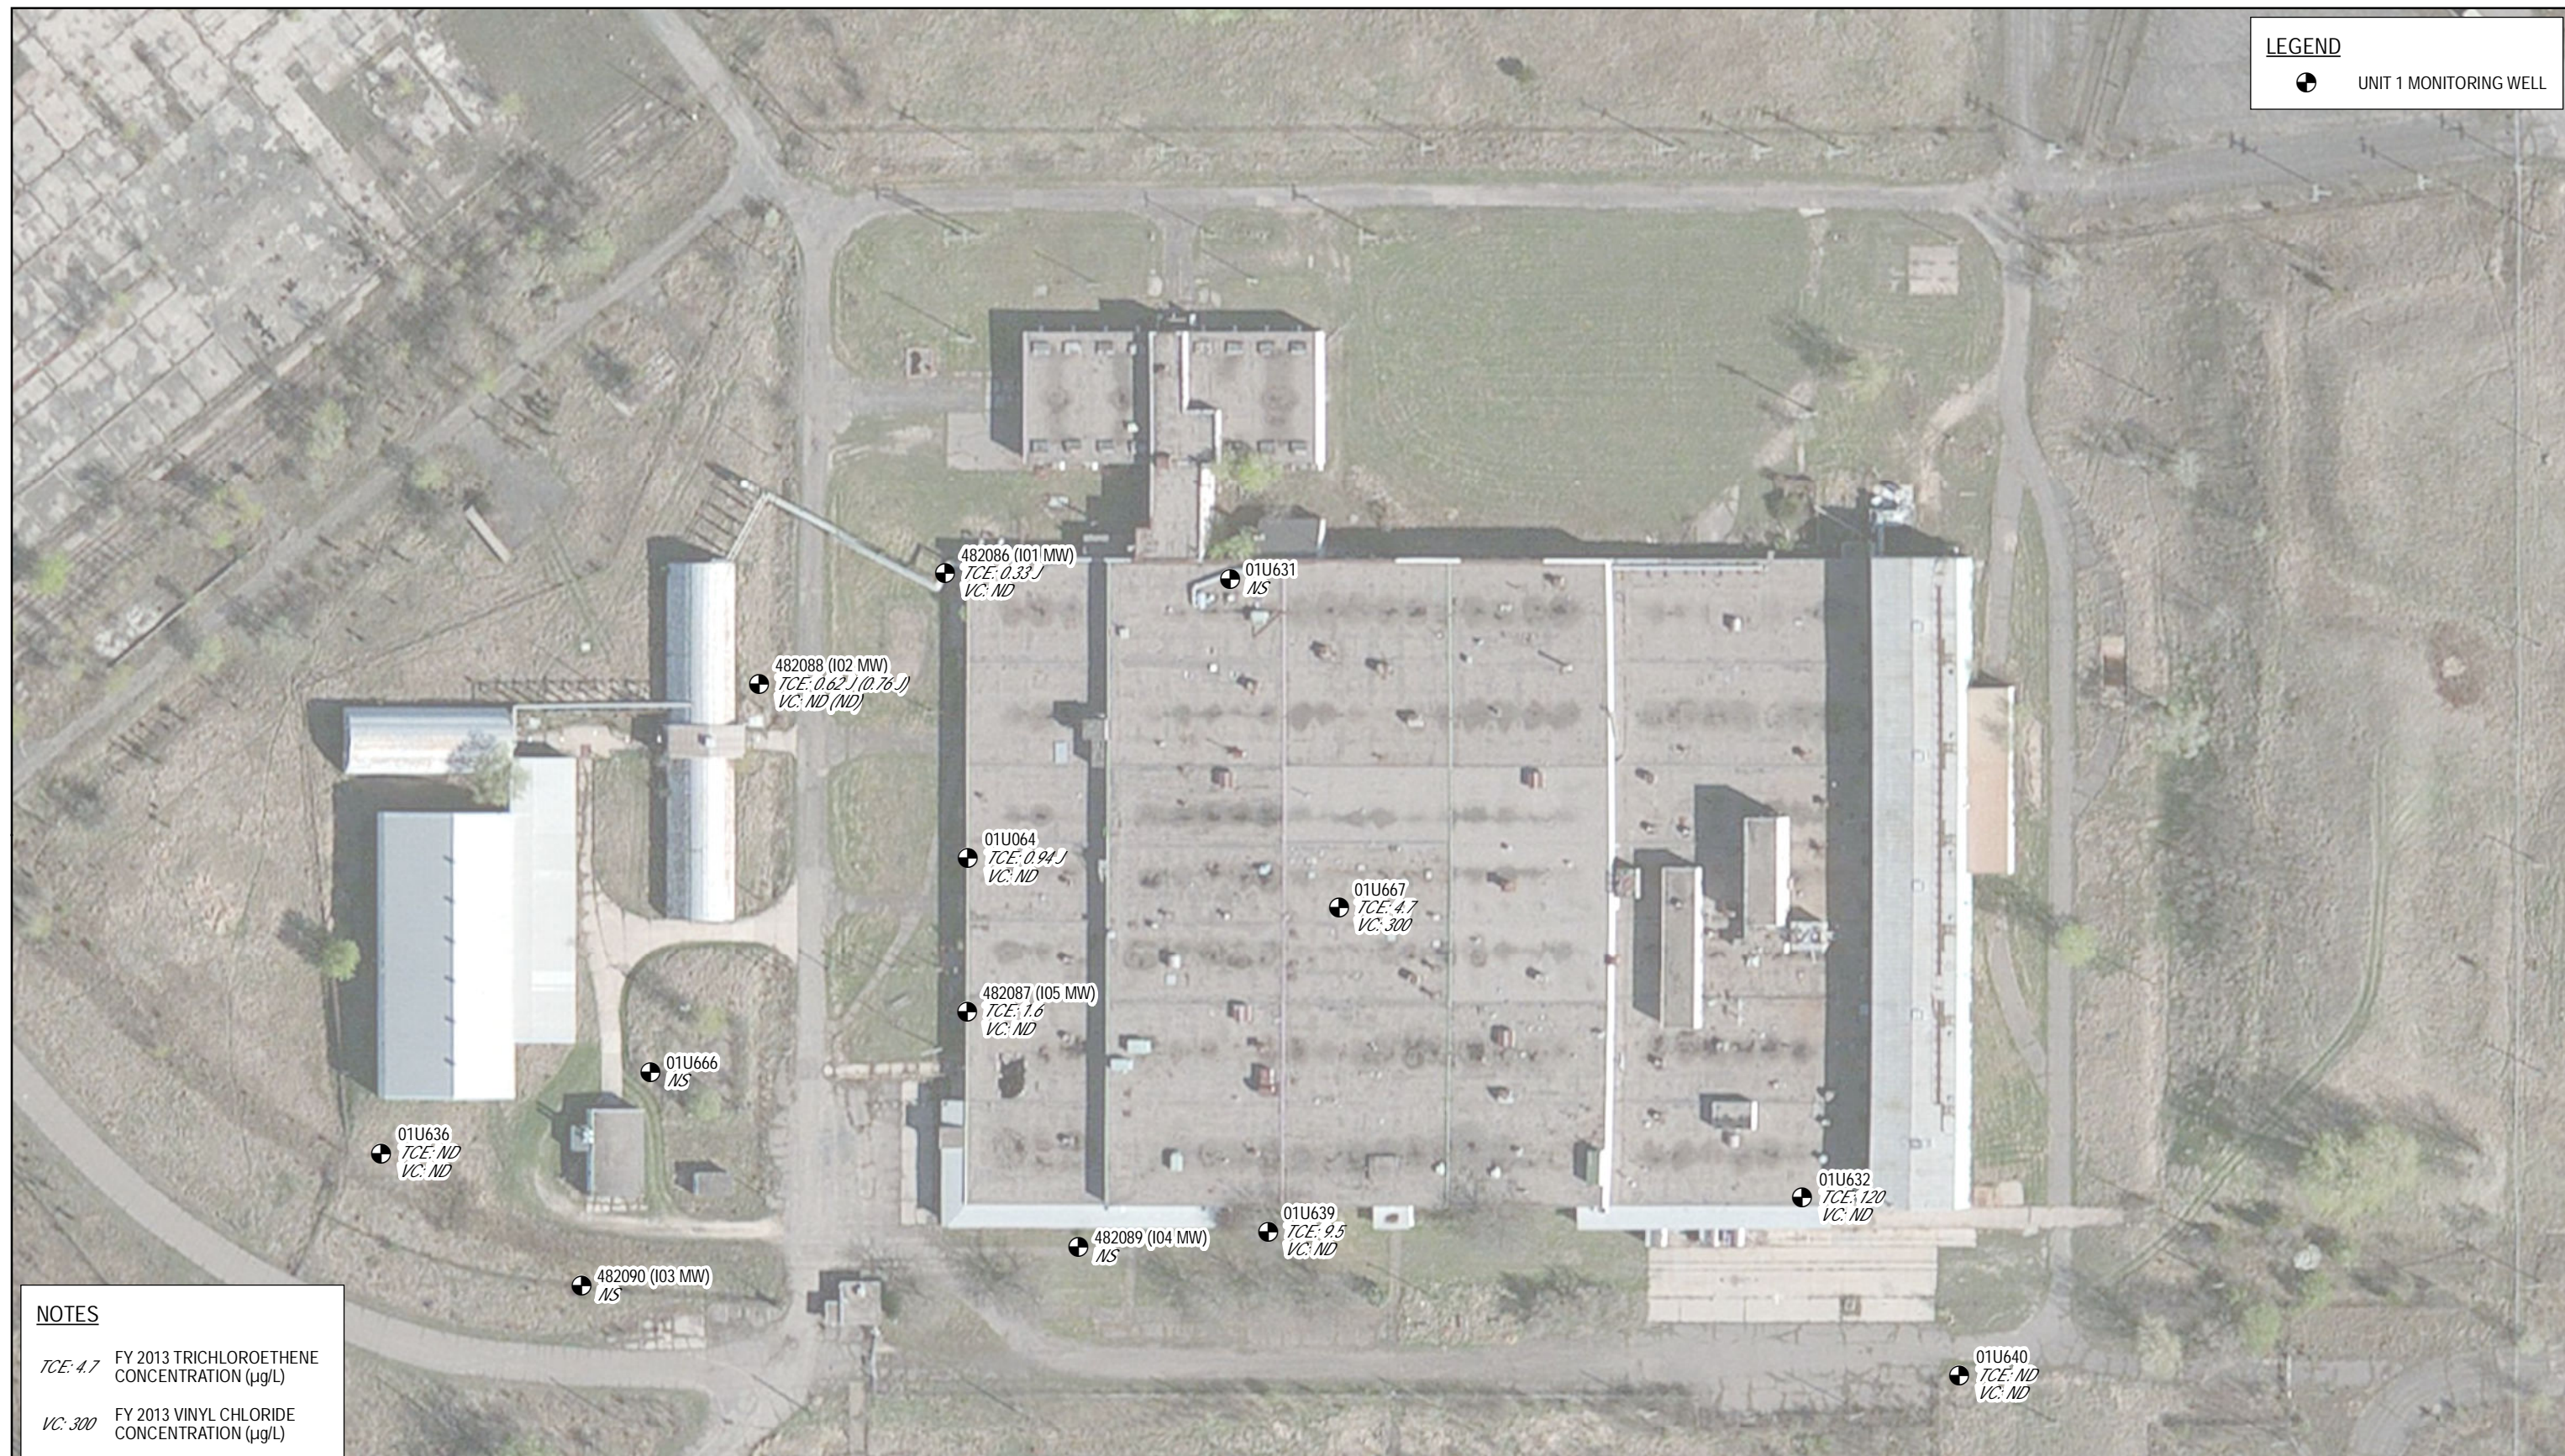
FIGURE 7-3

- TCE: 4.7 FY 2013 TRICHLOROETHENE CONCENTRATION (µg/L)
- VC: 300 FY 2013 VINYL CHLORIDE CONCENTRATION (µg/L)
- J ESTIMATED CONCENTRATION
- (J) DUPLICATE RESULTS
- ND ANALYTE NOT DETECTED
- NS WELL NOT SAMPLED

No. Groundwater monitoring was not conducted in FY 2021 due to the approved abandonment of all Unit 1 wells related to Site I demolition activities; however, the most recent groundwater quality data (from FY 2013) suggests that cleanup levels have not been attained. Table 7-2 presents FY 2013 data and highlights values that exceeded the cleanup level. The concentration of TCE in former well 01U632 had decreased over time but was still above the cleanup level in FY 2013. Results from the sampling of well 01U667 indicated concentrations of 1,2-dichloroethene and vinyl chloride remained above the cleanup levels. Figure 7-3 presents the FY 2013 Site I shallow groundwater TCE and vinyl chloride sample results.

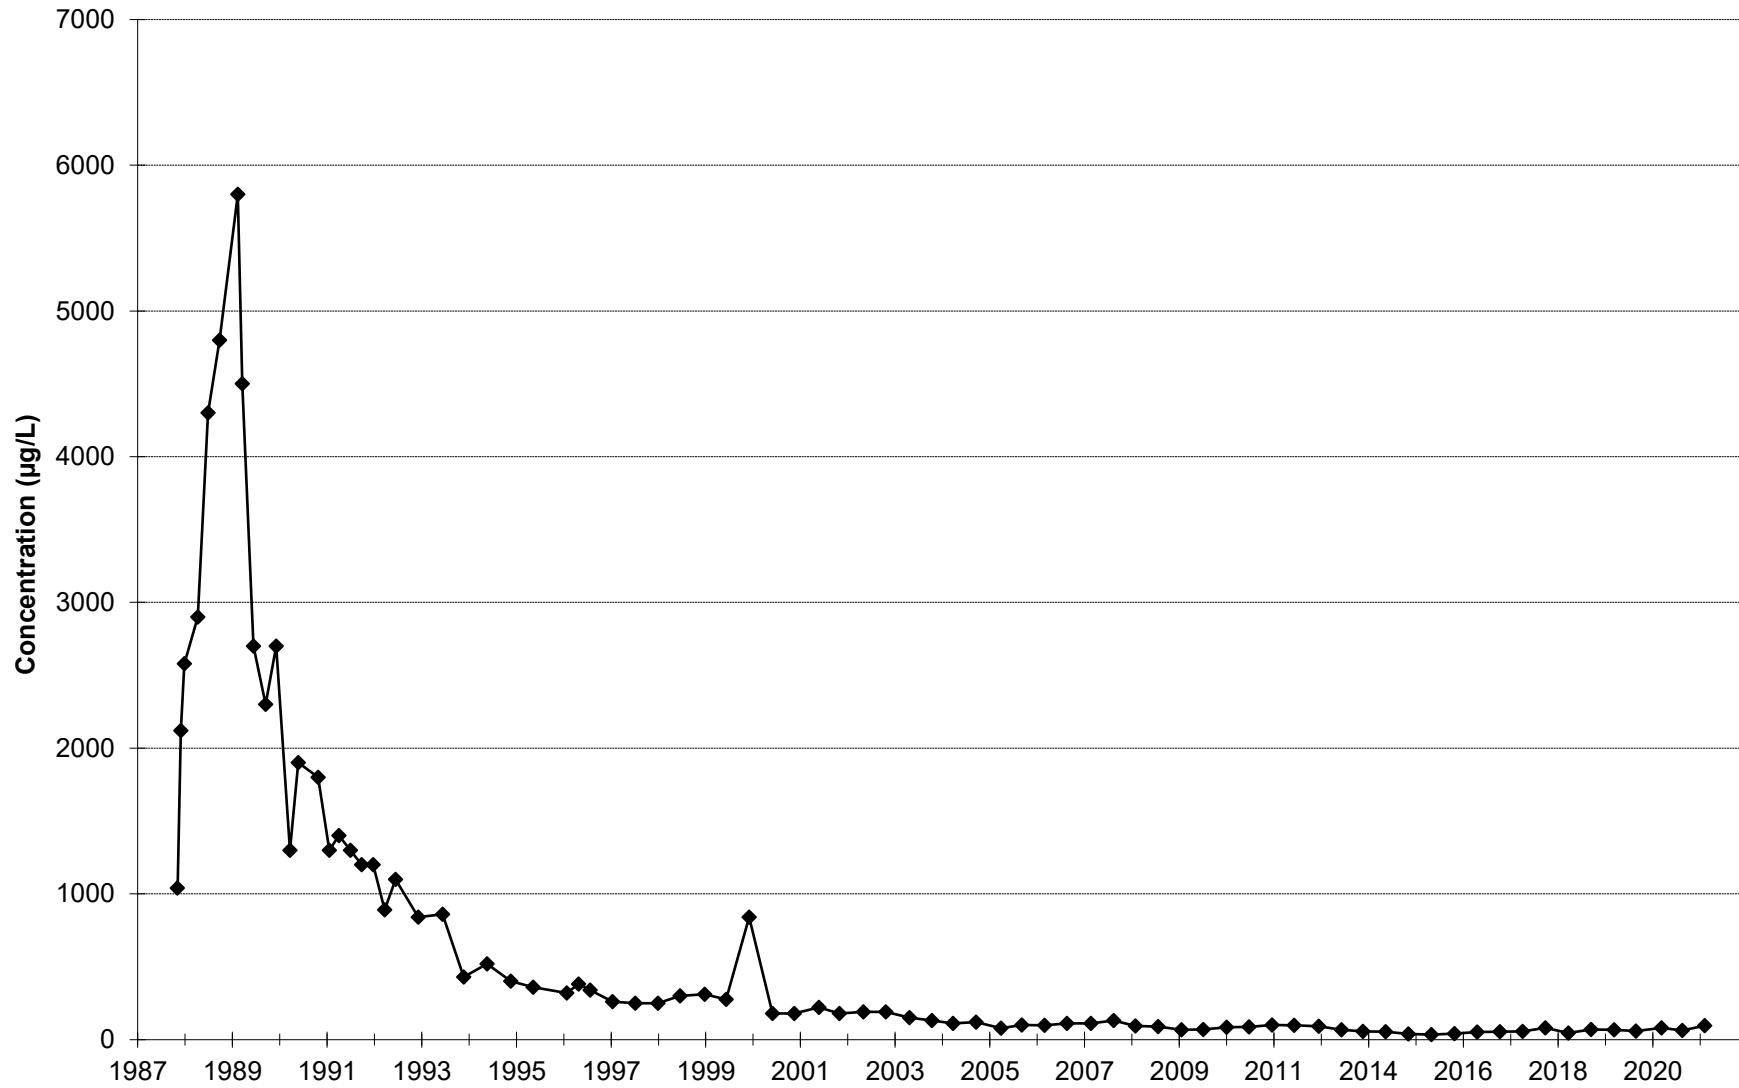
EXTRACTION WELL B1 - TCE VS.TIME

Note: Samples reporting concentrations less than the detection limit were plotted as zero.
